HEREFORDSHIRE ARCHAEOLOGICAL NEWS

HAN 43 January 1985

**WOOLHOPE CLUB
ARCHAEOLOGICAL RESEARCH SECTION**

PENTWYN HILL FORT – A FIELD SURVEY OF THE EXISTING REMAINS

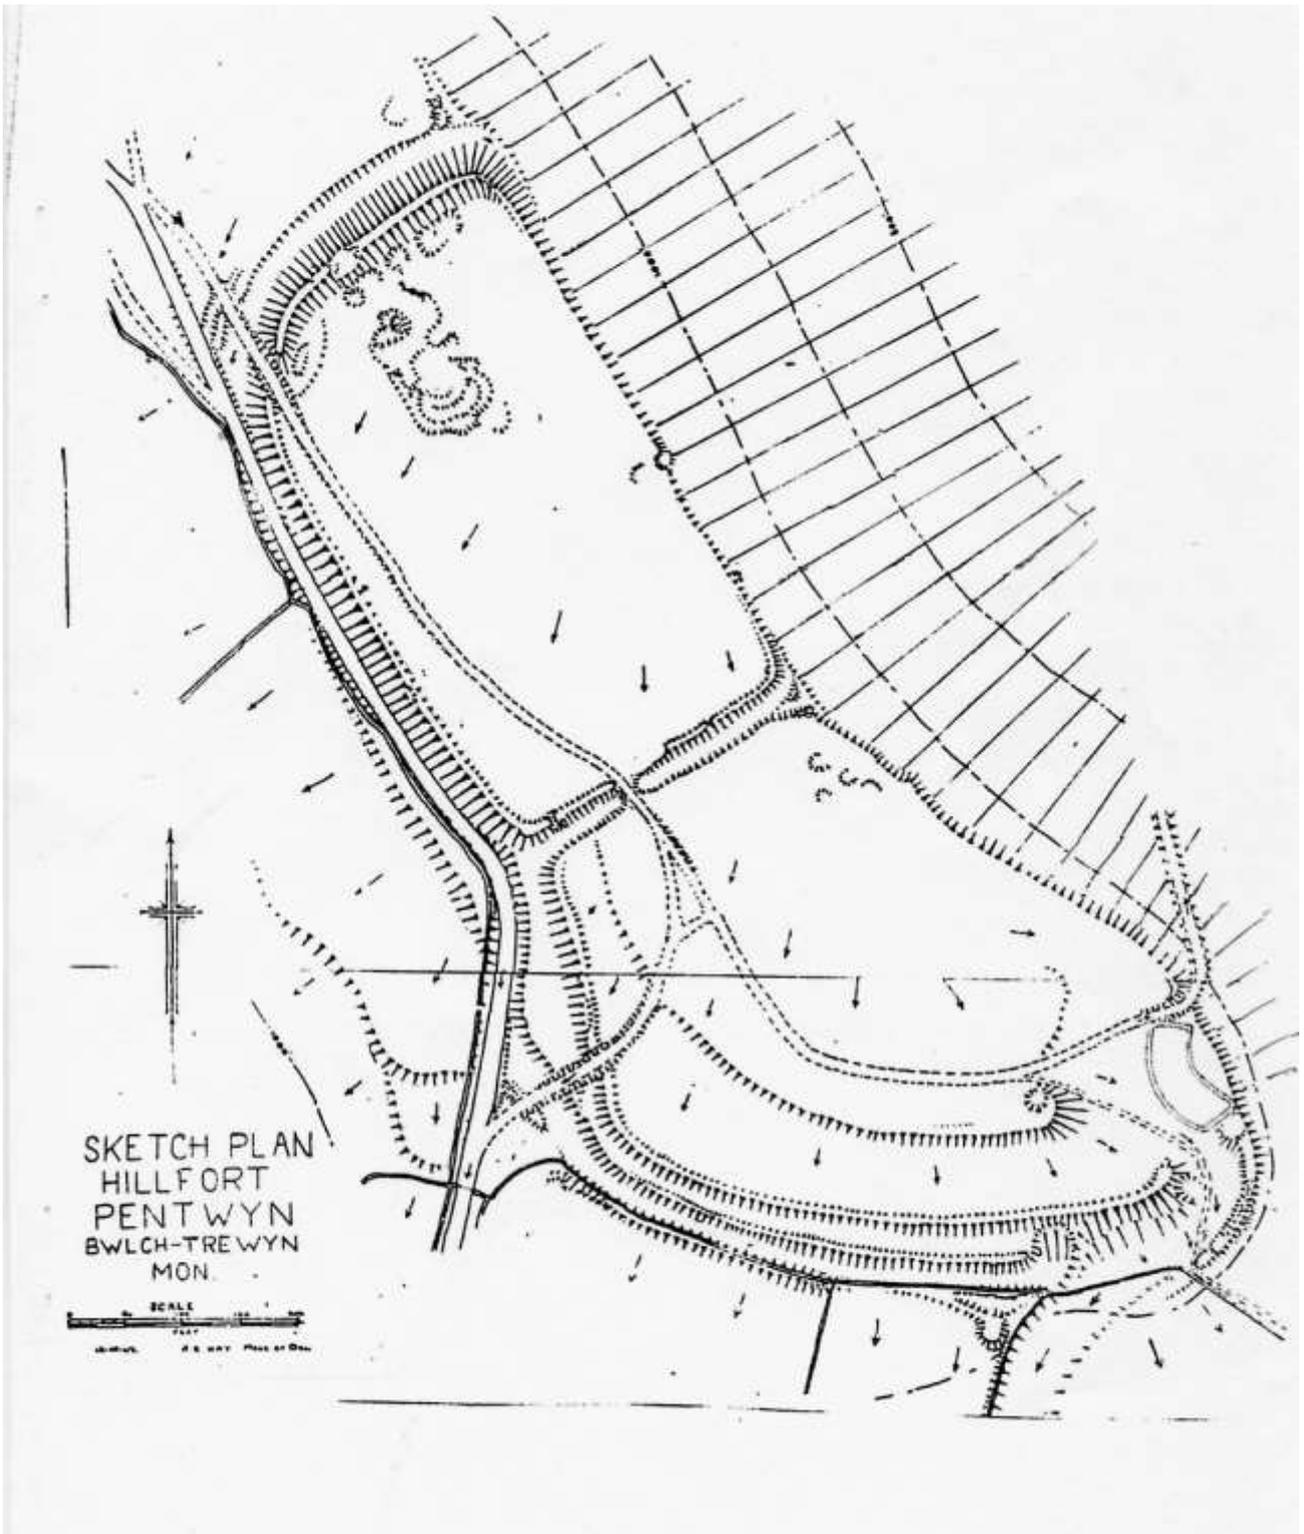
SKETCH PLAN
HILLFORT
PENTWYN
BWLCH-TREWYN
MON.

SCALE
0 10 20
YARDS
A. S. WATTS, F.R.S.E., 1904

Pentwyn will be seen to be a rather remarkable hill fort of a somewhat irregular, elongated plan with some curious complexities in the lay-out of its defences, whose surface remains would seem to indicate some complications in the development of the site over the period of its occupation; which probably extended over the last four or five centuries of the pre-Roman Iron Age. It could be suggested from the visible surface evidence that its defences were drastically remodelled at least twice during this time. The first probably took place during a period (perhaps phase is a better word to use!) of expansion and the second following a subsequent period of contraction. The earthwork seems to belong to that group of Brecknock and Monmouthshire hill forts showing a main enclosure sub-divided by cross ditches and ramparts, of which Castell Dinas (1) and neighbouring Twyn-y-Gaer (2) are supreme examples. Like the latter, its defences are, in part, bivallate.

The defences of the suggested Initial Phase or Phase 1 of the occupation of the site seem to have been largely obscured by later alteration and destruction, but it was probably a single large univallate enclosure with its defences following the N and W ramparts of the present northern subrectangular 'enclosure' or division of the hill fort and then sweeping round to the SW and S along the line of a low scarp within the present southern sub-division of the hill fort. This scarp would seem to indicate the site of an early and subsequently levelled rampart. There are still fairly substantial remains of what appears to be an original entrance on its SE segment.

During a suggested Phase 2, the enclosed area of the defences was further extended to the S and SW after the apparent slighting of the defences of Phase 1 in this portion of their circuit. The new defences, being constructed further out and lower down the hill slope, consisted of an inner rampart below which was a wide berm or terrace, and an outer rampart defended by a ditch and counterscarp bank. The wide intervening space between the two ramparts may indicate an attempt at constructing in an economic manner defences in depth. The single entrance remained at the SE of the defences close to the E escarpment of the ridge and in line with the entrance through the demolished Phase 1 rampart.

A suggested Phase 3 seems to indicate a late and considerable contraction of the site. A new straight ditch and rampart was dug E to W across the narrow waist of the previously defended area, thus forming the present N sub-division of the hill fort, an almost rectangular area. The N and W ramparts of Phases 1 and 2 were retained and that on the N probably at this time increased in height. During this phase the S defences of Phase 2 seem to have been neglected if not totally abandoned and the area of the S sub-division no longer used, at least in a defensive sense.

In now giving a little more detailed description of the earthworks, it may be said that on the E side of the hill fort the mountain slope is of such precipitous steepness that no artificial defences other than a little scarping and possibly a palisade were necessary.

The N sub-rectangular 'enclosure' or sub-division, as has been previously stated, seems by the comparative completeness of its defences to represent the final modification of the hill fort. The S end of the Pentwyn ridge has been separated from the level and then gradually rising ground to the N by a deep dry ditch and a formidable rampart constructed in one almost straight length of 200'. This rampart, of considerable proportions, still rises some 18' above the ditch and up to 10' above the interior. Although it might not compare with the monumental size of the S rampart of Gaer Fawr (near Newchurch, Mon), similarly built across the neck of a ridge, or the even more stupendous proportions of the defences of some of the larger Herefordshire hill forts, it is still an impressive work. On the W, after a modern break formed by a trackway, the rampart angles sharply round and runs in a southerly direction rising only 1' to 2' above the interior level but with a steep external scarp of 13'. It runs some 400', roughly parallel with the precipitous E scarp of the ridge, but bows outward slightly.

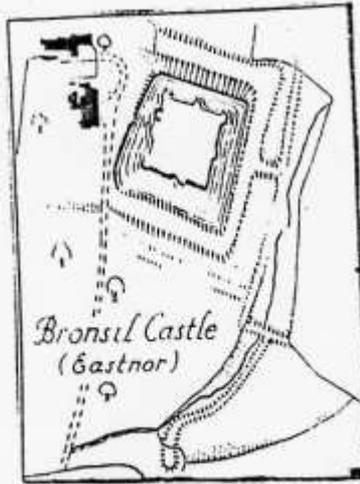
Bronsil Castle
(Gastnor)

The castle consisted of eight towers with curtain walls surrounded by a double moat. From the fact that the remains of the one gatehouse tower is octagonal, it would seem that Buck’s drawing of the castle showing the towers circular is incorrect. But it still gives a fair idea of what it looked like.

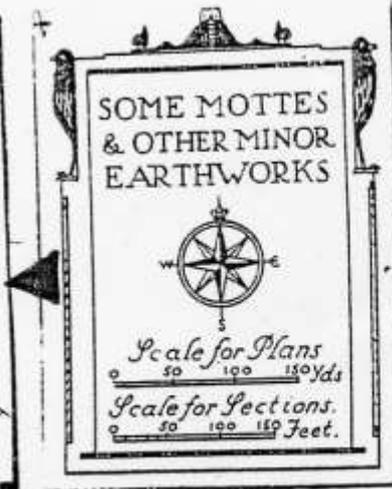
SOME MOTTES
& OTHER MINOR
EARTHWORKS

Scale for Plans
0 50 100 150 Yds

Scale for Sections.
0 50 100 150 Feet.

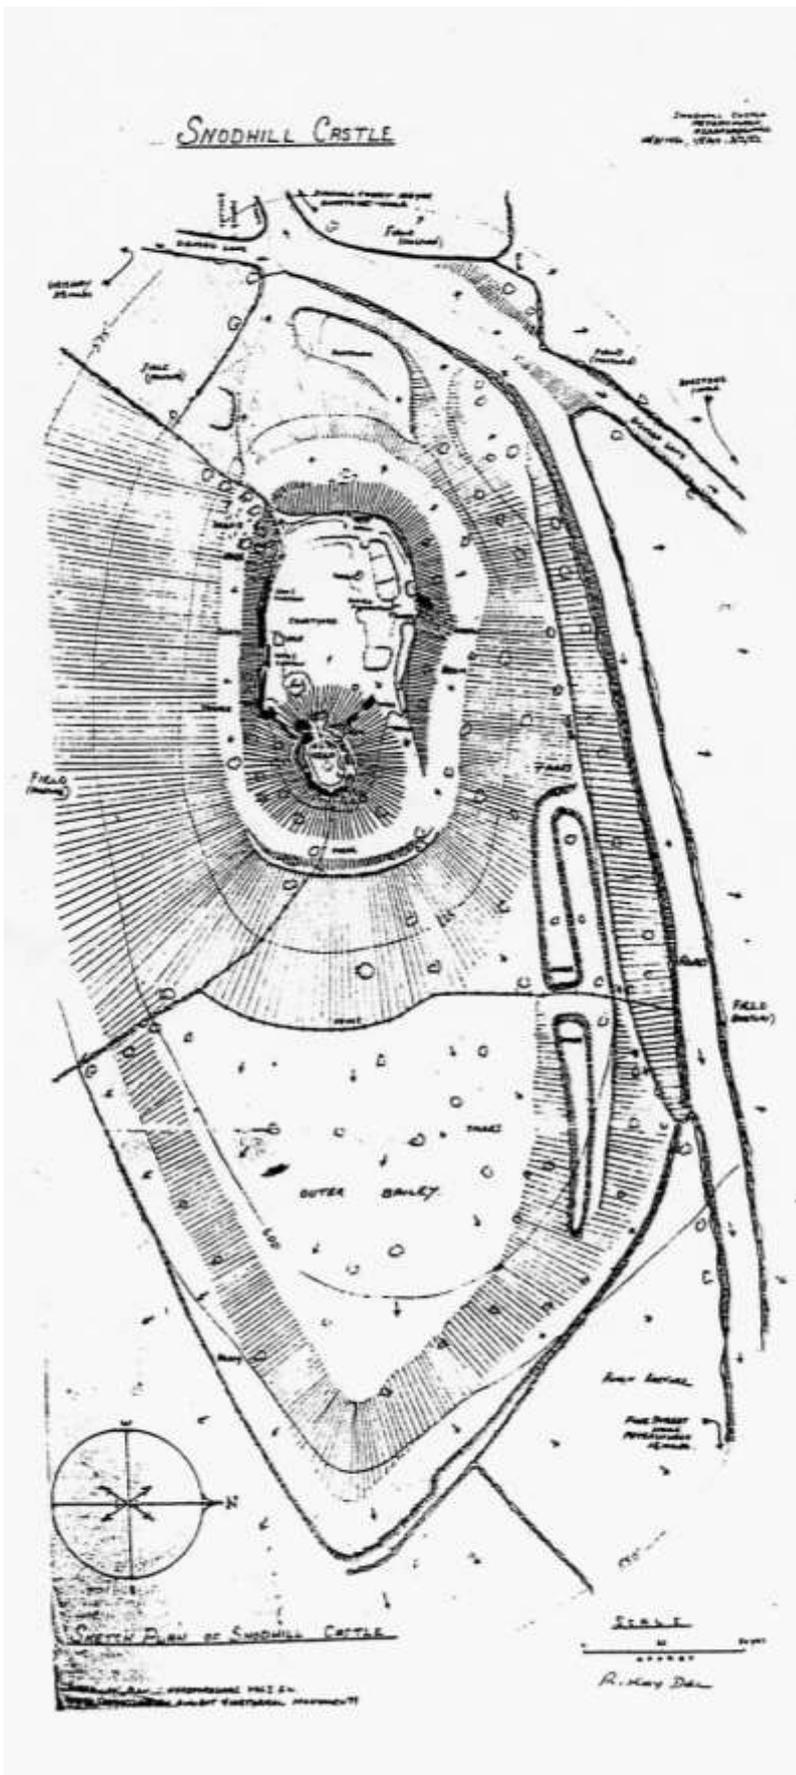
SNODHILL CASTLE

The Earthworks cover an area of approximately 10 acres. On the summit of the site stands an oval-shaped motte with a dry ditch on the E Side, and an irregularly shaped oblong bailey on the W side. The natural hillside has been steepened to form a scarp to the bailey, and around the base of the scarp runs a wide berm which widens out at the W end and appears to have a causeway leading up to the SW angle of the bailey. Below the berm the ground follows the steep slope of the hillside, which has been further scarped along part of the N side and strengthened towards the W end by a short length of ditch. Along the whole length of the northern slope, towards the lower half, runs a narrow berm or path which is continued eastwards for some 120 yards beyond the mound, with a bank and a ditch on the N side. At the foot of the slope on the W side of the bailey is a platform with scarped sides and with traces of a trackway leading up from it to the main berm below the bailey, but this may be of later date. On the E side of the scarp to the motte the natural slope flattens out into a roughly triangular area which may have been used as a outer enclosure; it is bounded on the NE and SE sides by the path or berm which is continued round from the N side of the site.

The Keep stood on the top of the motte. It appears to have been on plan an irregular ten-sided polygon with a projecting entrance gateway at the W end flanked by two circular towers or bastions. The remains are fragmentary and are of stone rubble. The plan of the southern side can still definitely be seen, but the outline of the northern walls can now be only approximately traced. An internal offset at the level of the entrance floor shows that the basement was, internally, octagonal on plan. The lower part of the S side of the entrance remains. It consists of the SW circular flanking tower, which has a straight joint between it

and the main wall; on the N face are the jambs of the outer doorway with the grooves for the portcullis and the haunch of a pointed arch above; farther E is the projecting jamb of an inner doorway with the slot for the drawbar; above this the ashlar angle and part of the reveal of a window or recess above the gateway are visible. At the SE angle of the keep is another lofty fragment of masonry with a small square-headed chamfered window at the basement level. Between these fragments only the lower portion of the walling exists, showing an external battered base, while at the SE angle are the remains of a buttress of later date. Small portions of wall remain above the ground level and give the approximate line of the walls on the E and NE.

The Bailey was surrounded by a stone curtain wall, and considerable fragments of this remain. From the NW and SW sides of the keep the curtain ran down the sides of the motte. The southern wall exists almost for its full height, but only a fragment of the northern wall now remains. About half the length of the original S wall of the bailey is still standing, the eastern portion having been demolished in the 14th century and a new wall erected slightly in advance of the older wall, with a circular bastion at the SE angle of the bailey where it butts against the wall running down the S side of the motte. The 14th century wall is faced with ashlar, and inside the bastion is part of a square-headed recess. The greater part of the older or W half of
