# HEREFORDSHIRE ARCHAEOLOGICAL NEWS

HAN 76      2005

WOOLHOPE CLUB  
ARCHAEOLOGICAL RESEARCH SECTION

## **Field Meeting to Whitchurch, Llangrove and Glynston Chapel by Roz Lowe**

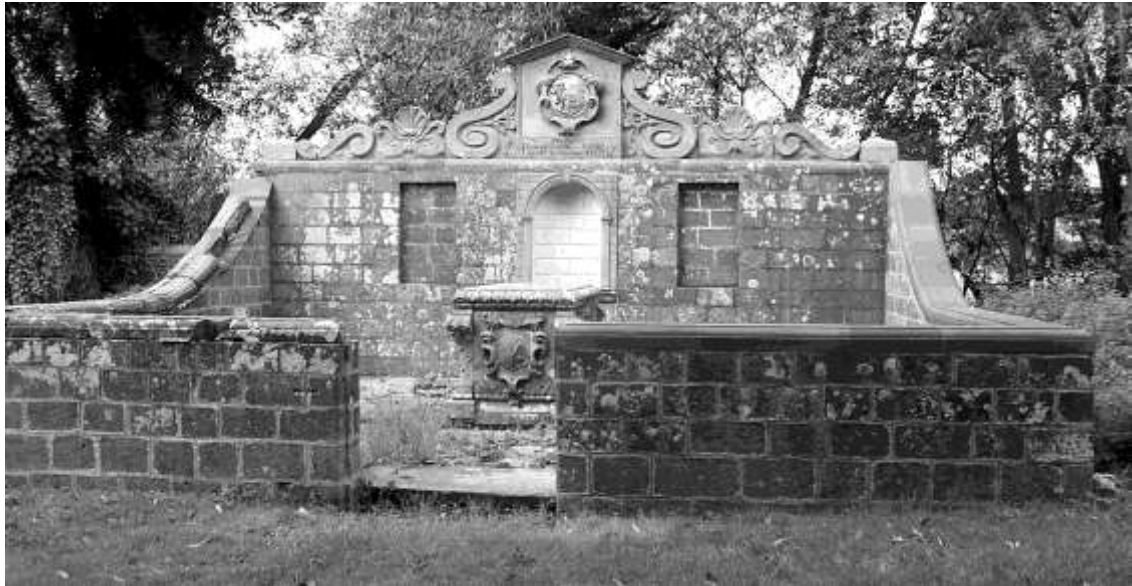
Figure 5 The Gwillim grave enclosure

The Simcoes are not buried in Whitchurch, but the Gwillim grave is a handsome monument to a wealthy local family. At the time of the field meeting, only the coping of the right hand side of the grave enclosure had been replaced, funds are awaited to finish the work. The grave is well built in sandstone, with a finely carved and coloured armorial.

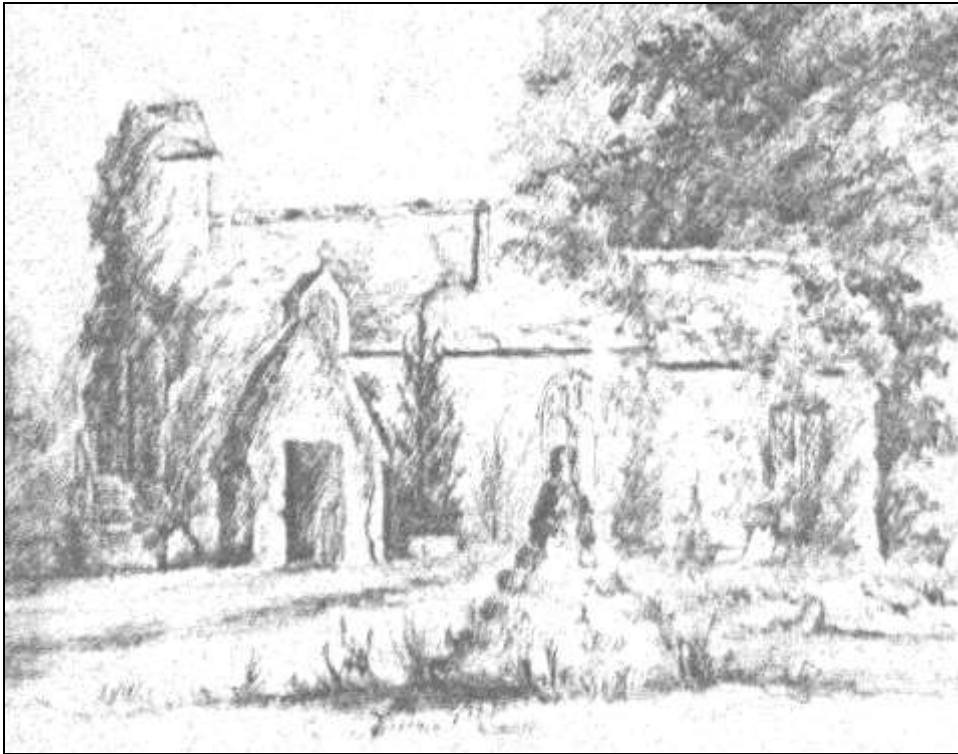
Figure 2 St Dubricius from drawing in church (from S, probably 18th C) ©Whitchurch PCC

The early sketch also shows a window above and slightly to the right of the porch, which itself is narrower and less ecclesiastical looking than the 1861 replacement. The window behind the cross in the drawing is now somewhat different. It seems possible that the roof was lowered when the church was re-roofed in 1860/1, though the earlier roof timbers were re-used. These show evidence of nails so presumably the roof timbers were not exposed.

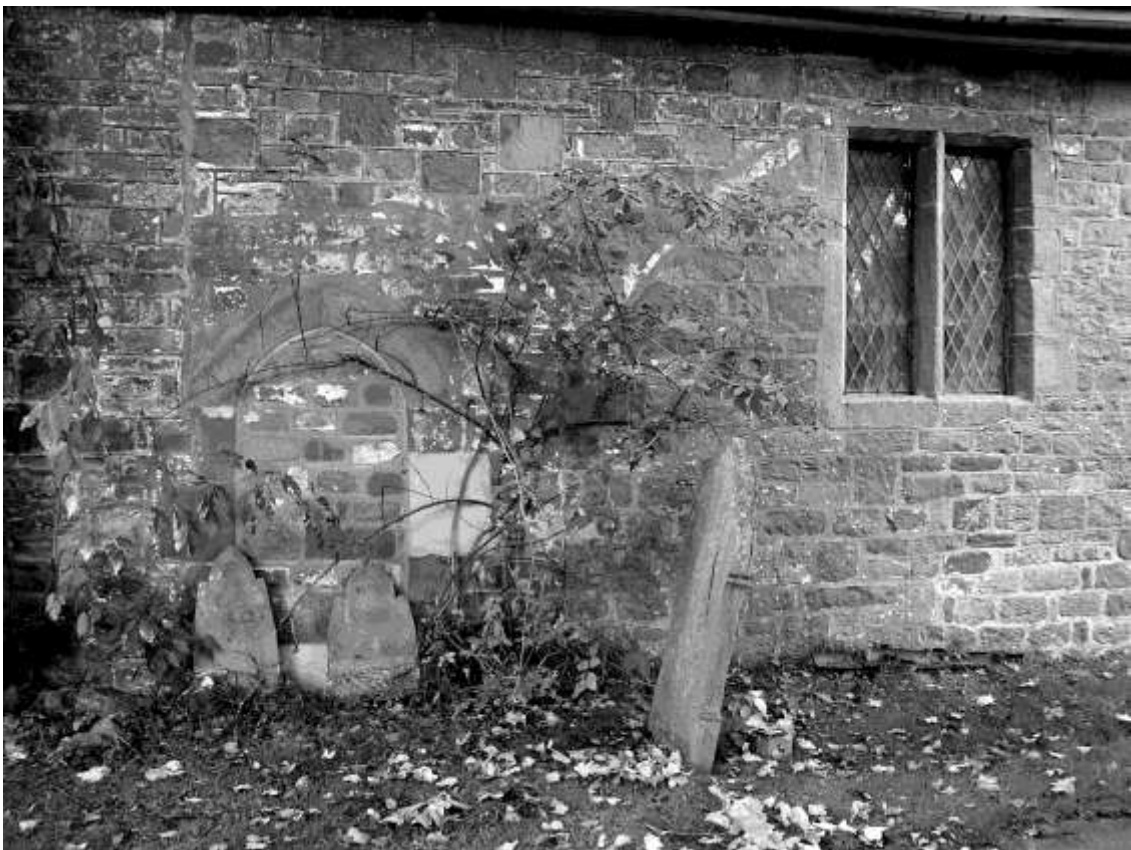
Figure 3 S wall of the nave

The situation of the church is precariously near the river. It is quite possible that this position is getting worse as the flow of the river around the curve erodes the bank, and one could speculate on how much has gone in the past 1000 years. The plan (Figure 7 Plan of St Dubricius) indicates the position of a 13<sup>th</sup> C chapel on the south of the chancel, which according to RCHM was demolished in the 16<sup>th</sup> C, at which time the central column of a two-bay arcade leading to the chapel from the chancel was incorporated into the fabric of the wall – RCHM thinks it to be *in situ*. The nave and chancel are believed to have been largely rebuilt in the 14<sup>th</sup> C. The embedded column is somewhat low compared to the current floor level, and it is interesting to speculate that the 14<sup>th</sup> C rebuilding raised the floor in response to a disastrous flood.

A possible scar of the removed arcade into the S chapel can be seen on the outside wall, and a door now blocked – see figure above.

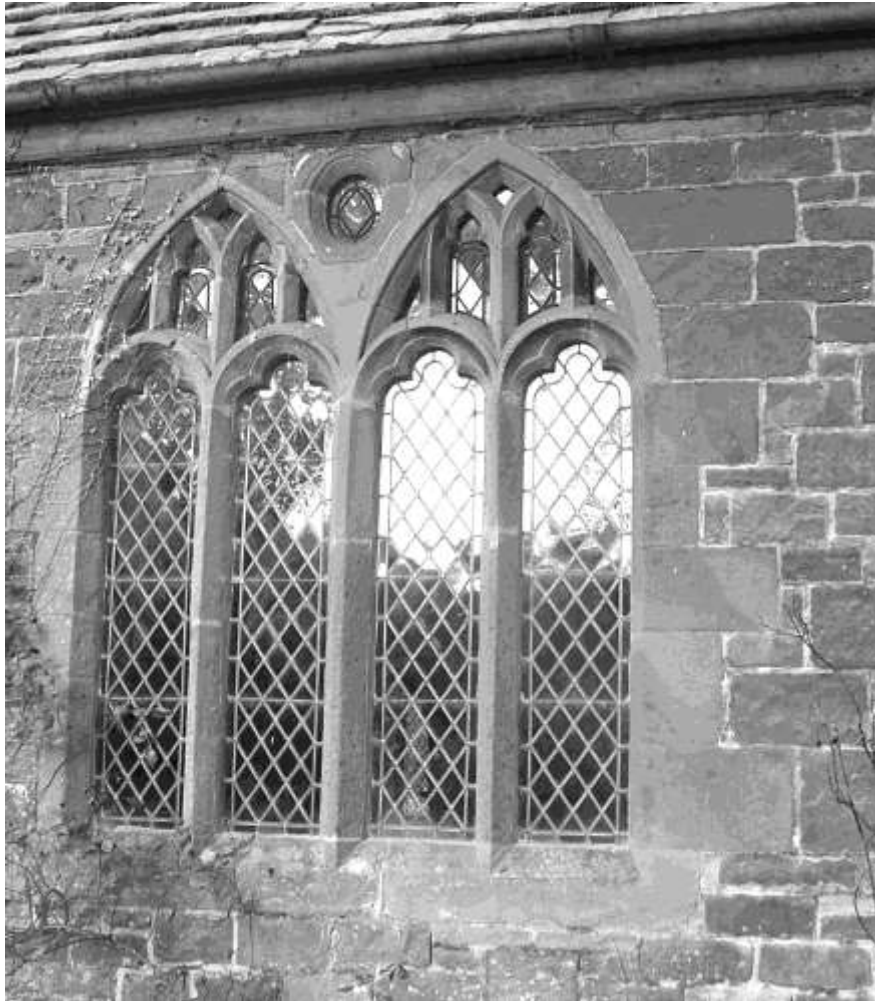
Figure 5 Eastmost window in S nave wall – compare with the sketch

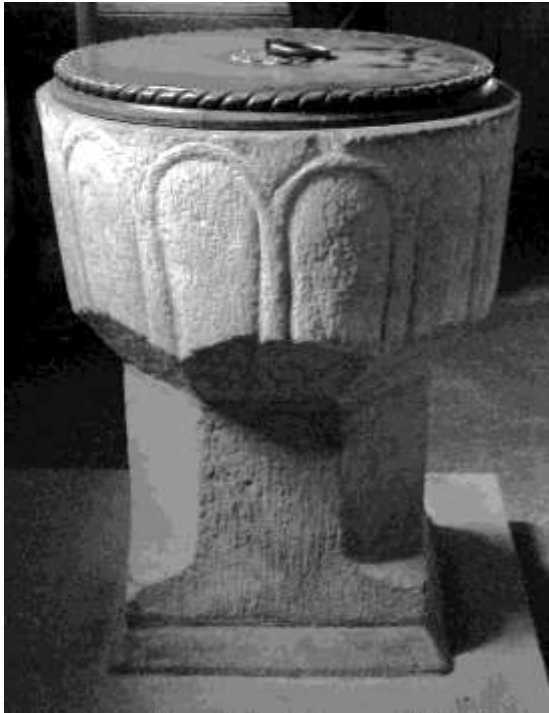
Figure 6 12th C arcaded font

Assuming that the font *does* belong to the church, the style is unusually plain for a church which enjoyed the patronage of William fitzBaderon. Fonts carved in a particular Romanesque style are found in Herefordshire & surrounding counties, and they have been identified as belonging to churches with a set of Norman patrons that included fitzBaderon.<sup>13</sup> However, the surviving Romanesque sculptures from Monmouth and Ruardean, another fitzBaderon church, are comparatively restrained.

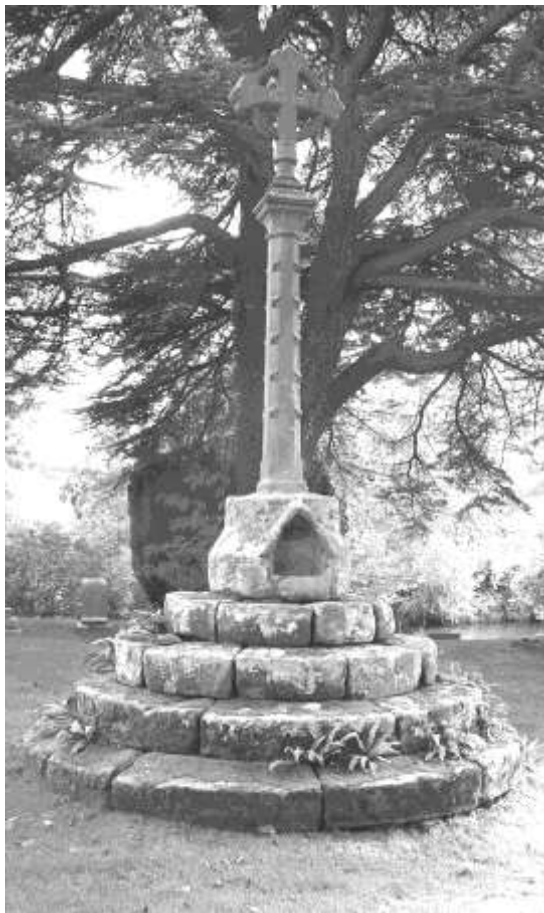
Figure 10 Cross

There is nothing that shows the original style of the top of the cross. The early (18<sup>th</sup> C?) sketch of the church can be found inside, which shows the top as a stump, but with the niche in its current position. The booklet on Elizabeth Simcoe shows a drawing of the church from the direction of the river supposedly made in 1791, but in it the replacement cross is in place, and the church has its current form of porch, windows and there is no chimney as seen in the earlier drawing.

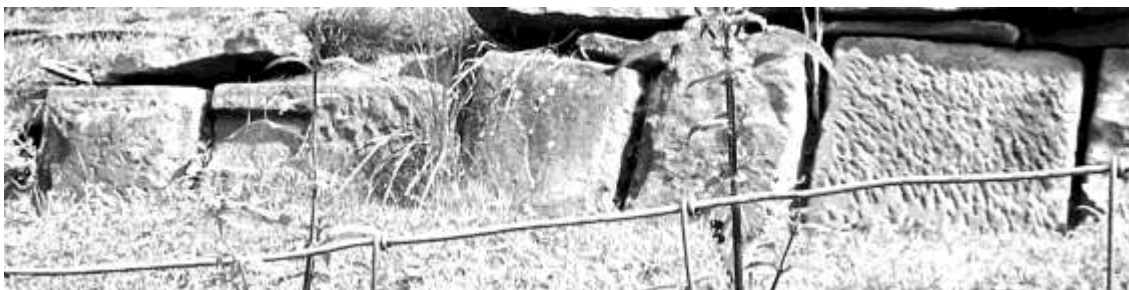
Figure 16 Dressed stones in garden next to Old Grove House

Old Grove common is bounded on the SW side by a small stream, which later joins that running into Whitchurch. The stream formed the boundary between the parishes of Welsh Newton and Llangarren before Llangrove was established, except in the SW corner, where the boundary follows the margin of a field which once contained a chapel, as is clearly shown on the tithe map. After sheltering in Old Grove House from a downpour, we made our way from the house (no. 654 on the tithe map) through the steep garden (651) to the stream. The barn adjacent to Old Grove House (shown in 651) has now been converted into a separate house. As we passed below its garden we could see some stones used as a border which were from a building (SO 5215 1925). It's believed (hearsay) that these stones were part of the ruined chapel which had been in a pile the field below, and were re-used in the 1980s.

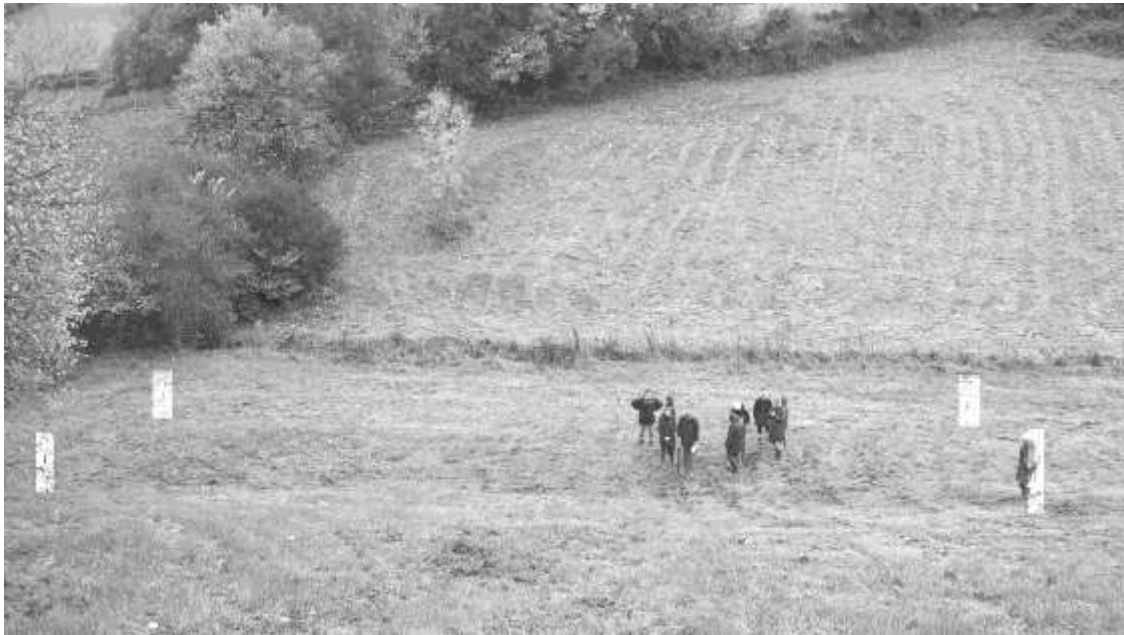
Figure 18 Measured rectangle from tithe map, ranging rods at corners highlighted

Using dimensions of the rectangle shown in the tithe map, and its relative position to the old established hedges, we used ranging rods to mark out the position of the rectangle on the ground. (next figure). It is surprisingly large for a chapel, some 81’ feet by 32’ (24.6m by 9.7m). It seems likely that these were the outside dimensions of the collapsed walls and the original building was somewhat smaller. The area marked is spuriously level near the stream where the original ground level was more sloping; at the side nearer the camera it is more sloping owing to recent earth moving.

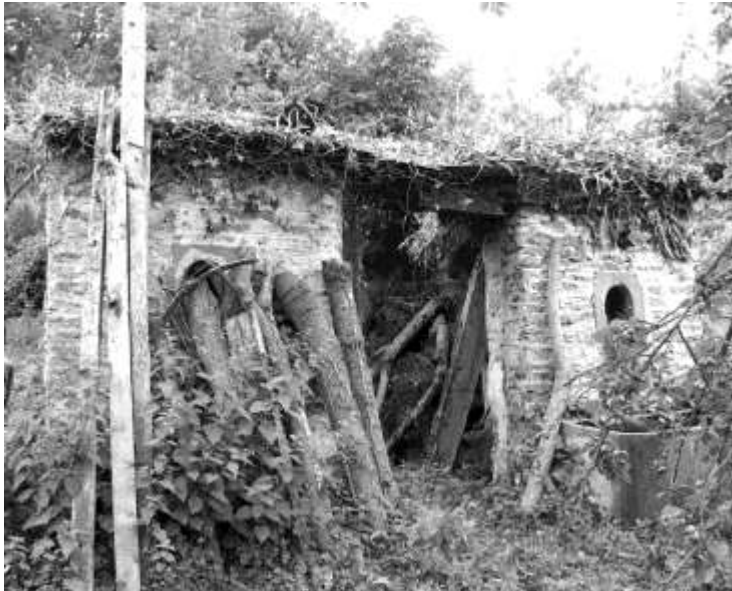
Figure 22 E wall of building

It was a garden shed, but of a superior order. About 4.5m square, from the evidence of a broken tile it was originally pantiled, though now slated, but its most unusual feature was its windows

The stone window frames could have come from another building. They are somewhat eroded, but this is usual for the local sandstone. It's possible that the vicar managed to get the stone masons working for Samuel Meyrick at Goodrich Court at that time to cut them for him. They resemble a 'window' in Y Crwys, the old manorial prison in Goodrich restored by Meyrick, though this was not done until the 1840s.

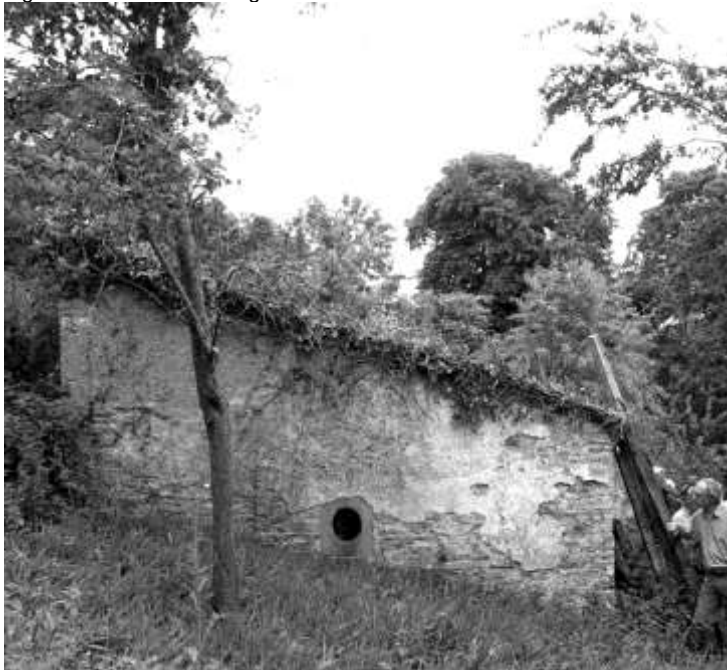
Figure 23 S wall of building

The building is somewhat sunken into the hillside on the W side, though this may be just from an accumulation of soil. The N and S walls each have a small sandstone-framed window (about 50 by 40cm and 10cm thick) with an oval aperture c28 by 23cm, with evidence of hinges for shutters inside. The two similar windows flanking the door in the E appear not to have had shutters. The original door is gone..

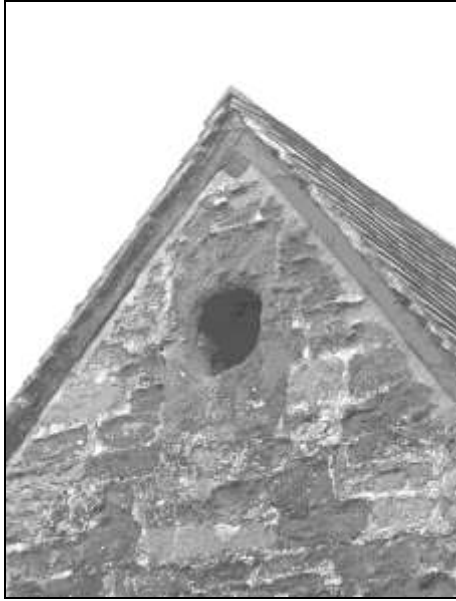
Figure 24 Gable end of Y Crwys

Y Crwys has never been a barn or similar building in which an owl hole is found – in any case, they're usually circular. The stone frame at Y Crwys appears to be somewhat larger than those in the vicarage garden building. It also appears to be original, although it is known that Meyrick had to do major repairs to the structure.

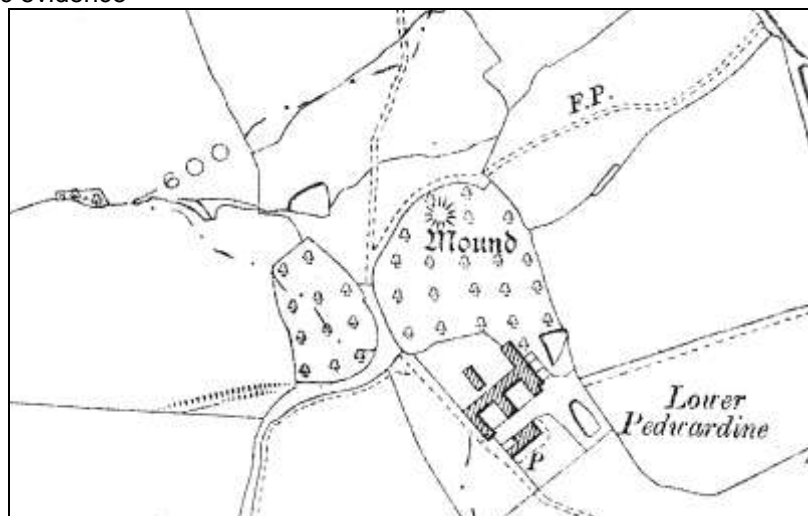
Figure 5 Lower Pedwardine detail

The platform on which the mound is set has a double step running roughly SW to E. This step, roughly 6 – 8ft wide, is full of buried stone and 20 years ago had several courses of facing stone showing. This suggests a long section of wall foundation fronting the motte area to the S/SE. In front of that is a sunken area with a bank or dam to the E. This may have been a wide moated area: it is still wet in winter. The mound, with part of its ditch and counterscarp bank still recognizable, has buried stone in it, and there is buried stone in the ditch. This points to the possibility of a former stone structure on the mound, which it would have to have had to be seriously defensible.

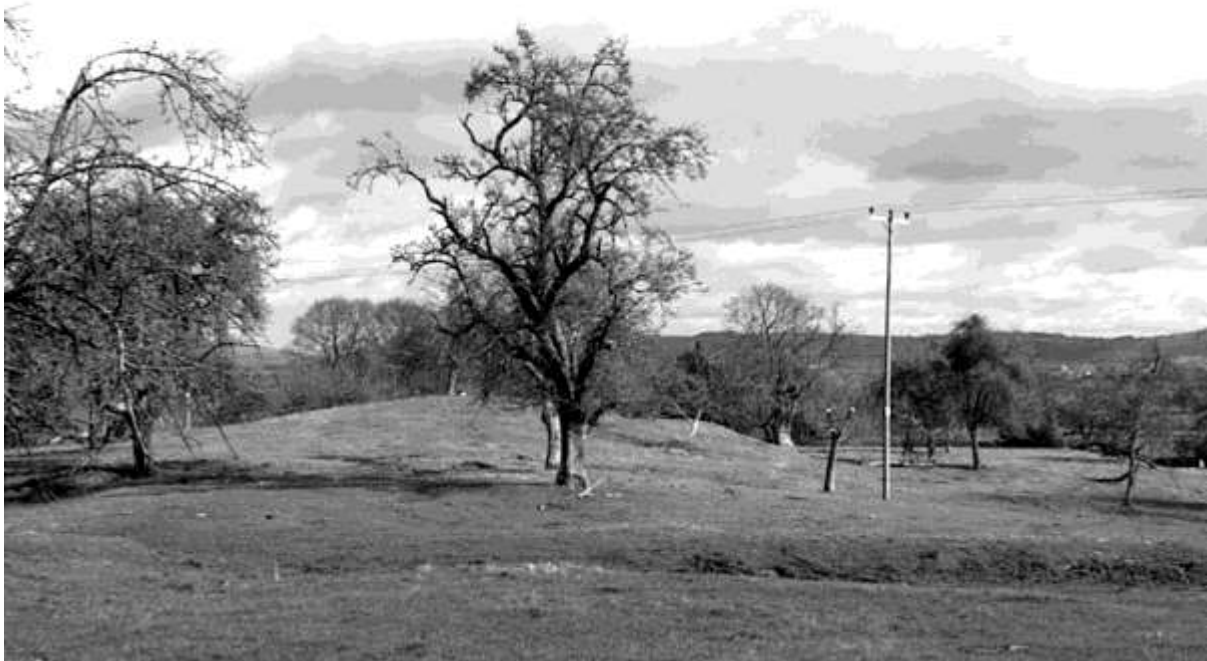
Figure 26 Lower Pedwardine mound from SW

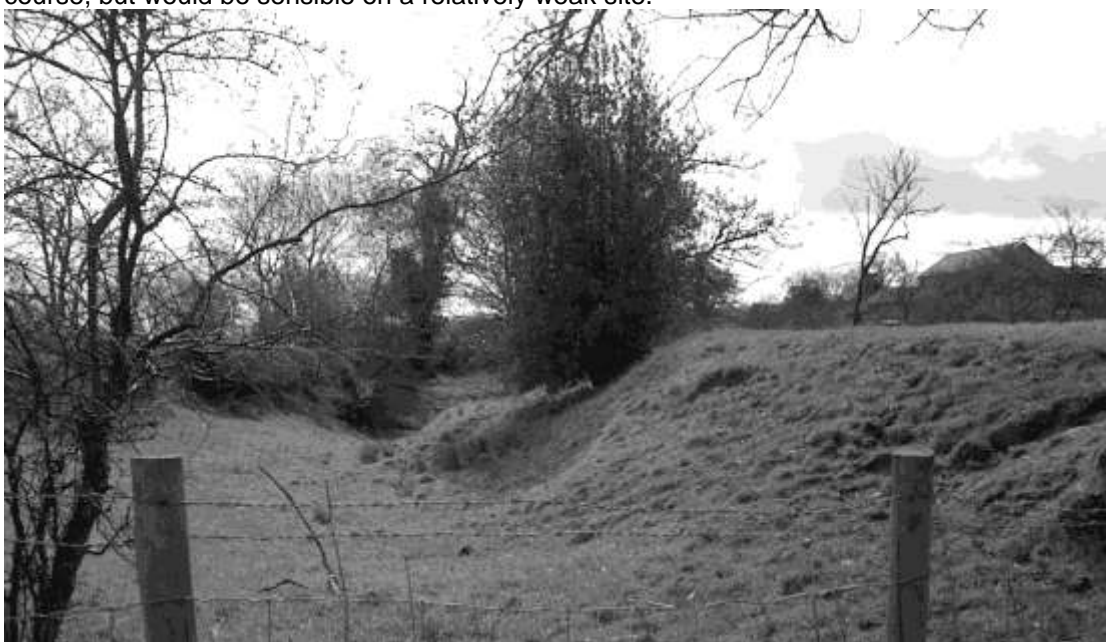
Figure 7 Ditch around site to the NE

The outer bank to the N, though overgrown, shows much loose stone on its slopes. There is the possibility that this is evidence of a concentric wall around the mound or even of a revetment to the bank. Either of these combined with a dammed stream forming a wide moat would form a formidable defence on the N side of the site. This conjecture is at present lacking evidence from excavation, of course, but would be sensible on a relatively weak site.

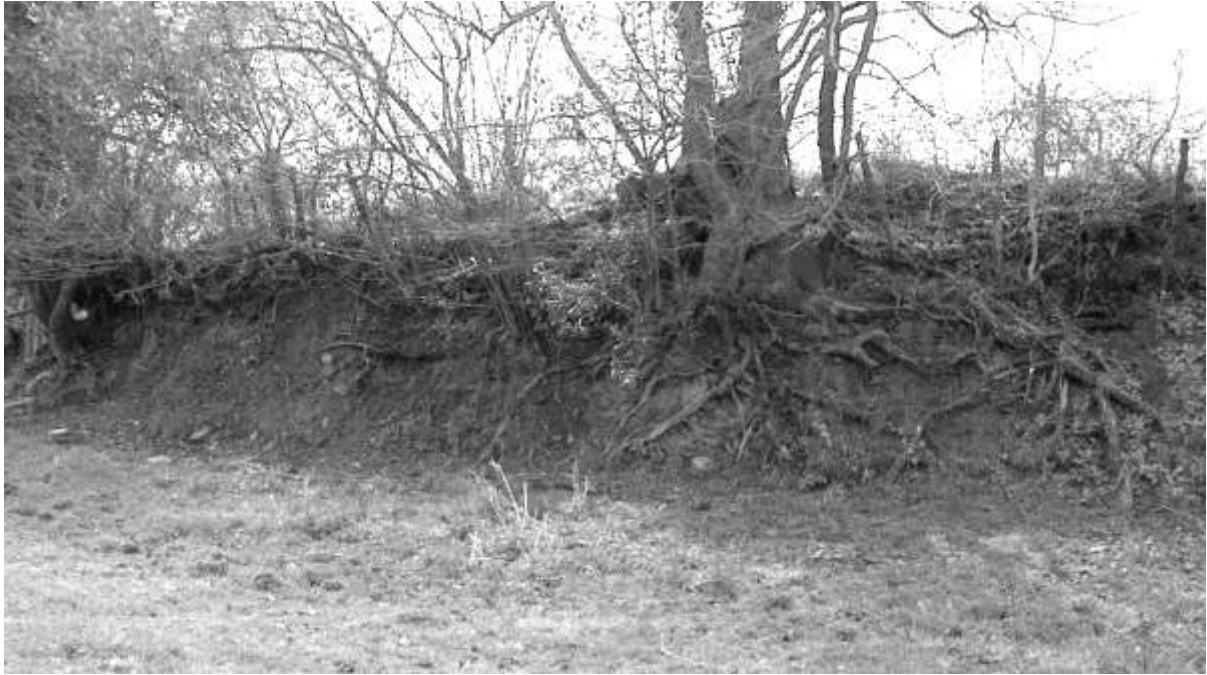
Figure 8 Ditch around the site to NW

A sunken track to the W of the mound platform may mark the position of a former ditch defence. However this area is difficult to read because of dumping of building waste, ash etc possibly related to the position of former farm buildings which show on an old map of the site. Amongst the buried and exposed rubble we found 2inch hand-made bricks (Tudor?) and fragments of brown-glazed Hereford ware pottery, late 15<sup>th</sup> – 16<sup>th</sup> century.

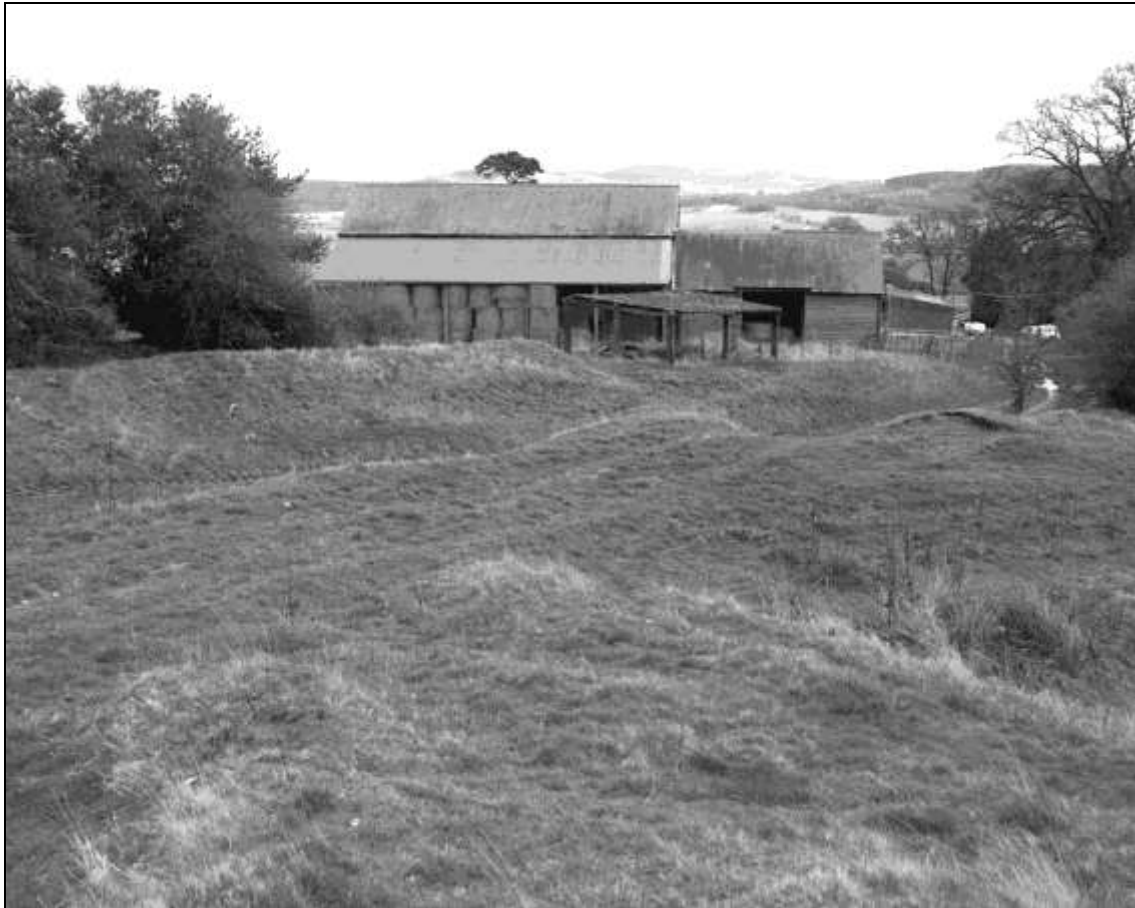
Figure 12 'Quarry' from W of farm buildings, showing sunken track coming in from W

On the western side of the site is what was thought to be a quarry for the site; an area of disturbed ground with much stone, loose and in situ. However our recent reappraisal of the site suggests a much more interesting possibility. Roz Lowe thought that the quarry seemed to have the outline of a former building. The writer, who should have known better as many sites of demolished castles have been called quarries, had accepted it as a quarry without examining it closely.

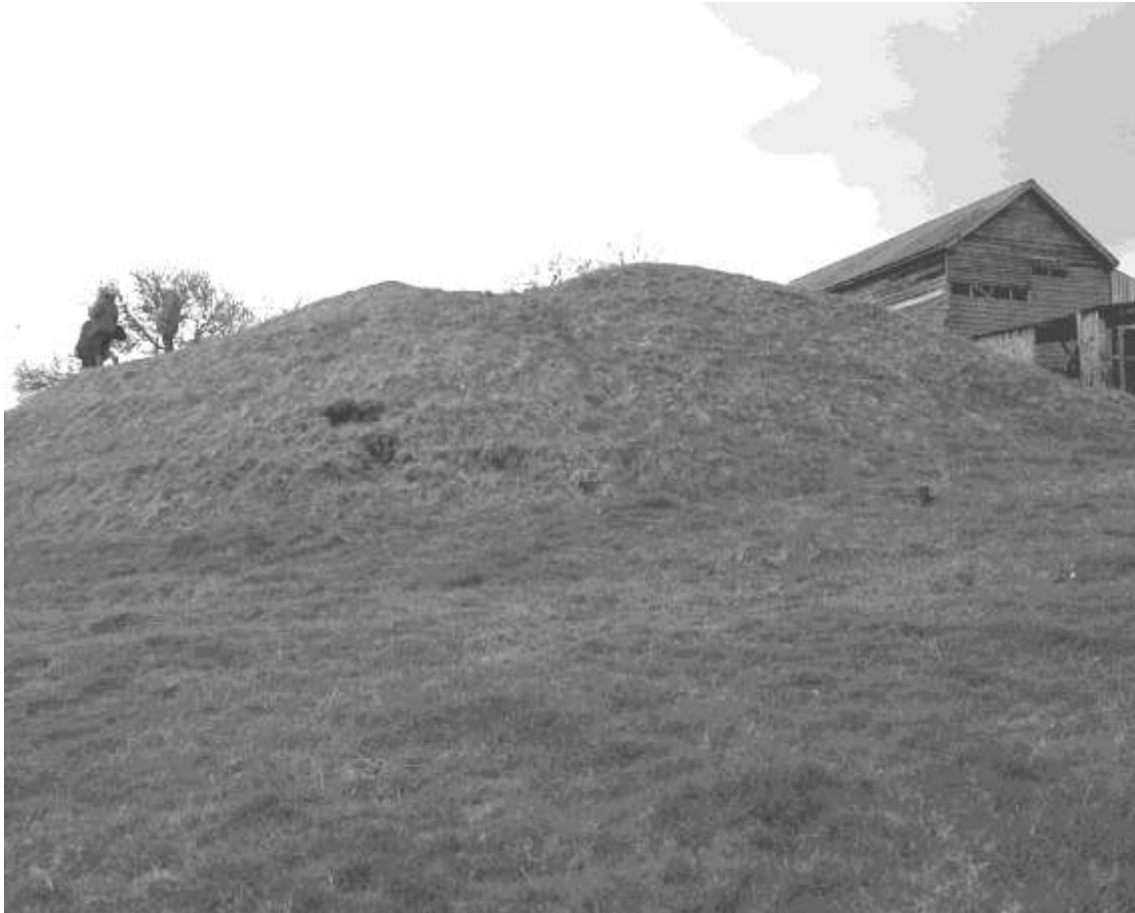
Figure 13 Motte from N

Whilst I was looking at the motte/mound and associated earthworks, he looked in the cattle shed which abuts and appears to cut into the mound. He had hoped that the face of the tower buried in the mound might show in the rear wall of the cattle shed. However the rear wall had been refaced in modern times, probably post WWII, with stone and concrete blocks.

Andrew called me into the shed as he had noticed some odd stonework on the floor. Looking at it closely we realised that we could have a surprising discovery here. There are what looks like a pair of similar foundations each about 20ft (6m 10cm) wide, underlying the modern brick wall of the cattle feeder trough. These foundations are roughly 10ft (3 metres) apart, symmetrically aligned to the mound, and close to it. The western one is semi-circular, disappearing under the modern wall. The eastern one is partly removed but shows the start of a curve. Together, they give the impression of 2 semi-circular or circular towers forming a fore building to the stairway to the buried donjon.

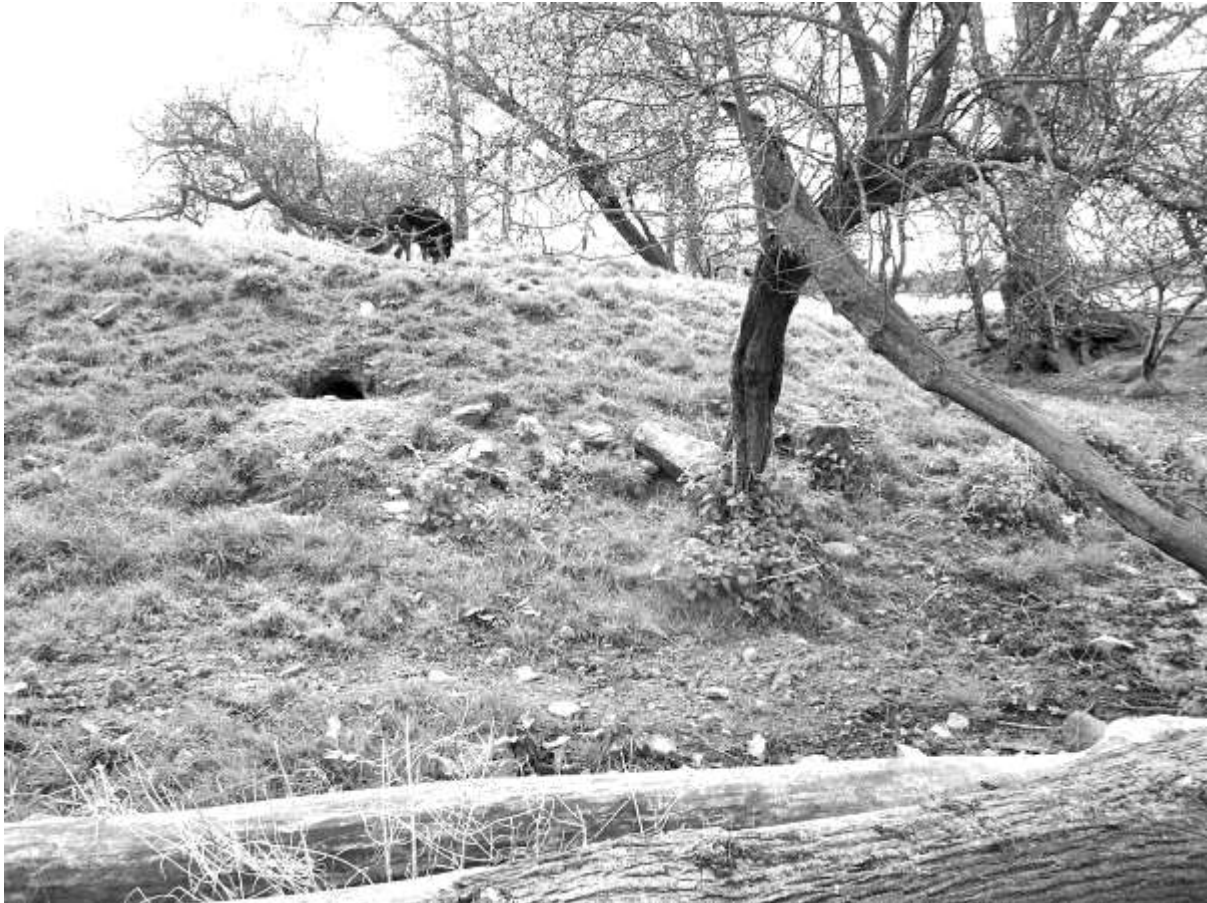
Figure 5 Field's Place moat and platform from E

This structure when complete would probably have been a lightly fortified house rather than a castle, but it may have had crenellations and looked like a small castle. There are several surviving examples around the country with the same dimensions. These vary from plain fortified houses to quite formidable little castles. (see comparison list below). A small piece of thin window glass was found in the spoil kicked out from a rabbit hole.

Air photos show a further moated platform to the SE connected to the above forming an outer enclosure or bailey. This would have contained the associated farm buildings and seems to have been the site of the farm until recent times when the present moated site was used as a garden.

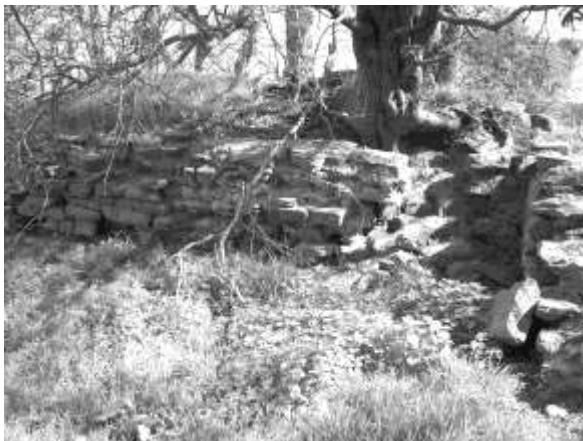
Figure 11 walls of 'mill' viewed from NW

The owner, Mrs Powell, informed us that the waterwheel was used to power machinery at the farm over 150 yards away through a system of shafts and gears. Access covers for maintenance can still be seen when walking up the field towards the present field buildings.

The intrepid Roz Lowe climbed down into the brick-built entrance of the tunnel leading off the former water-wheel pit to look at the structure. A slight hollow in the field indicates where a section of the tunnel has collapsed. The outlet from the tunnel is not obvious because of the collapse, but it probably enters the brook near the road.

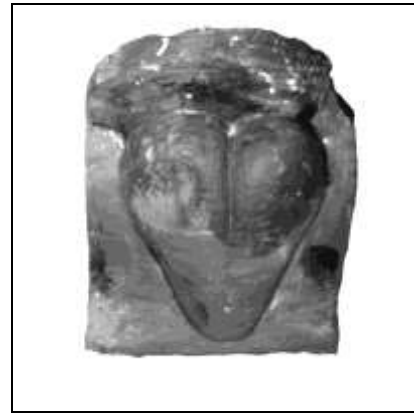
Figure 4 Stone heart in the chapel wall

An interesting object embedded into the chapel wall is a large stone carving of a heart - perhaps 20cm cubed. Roger identified it as a memorial to someone who died abroad – perhaps on crusade - and whose heart was brought back for burial.

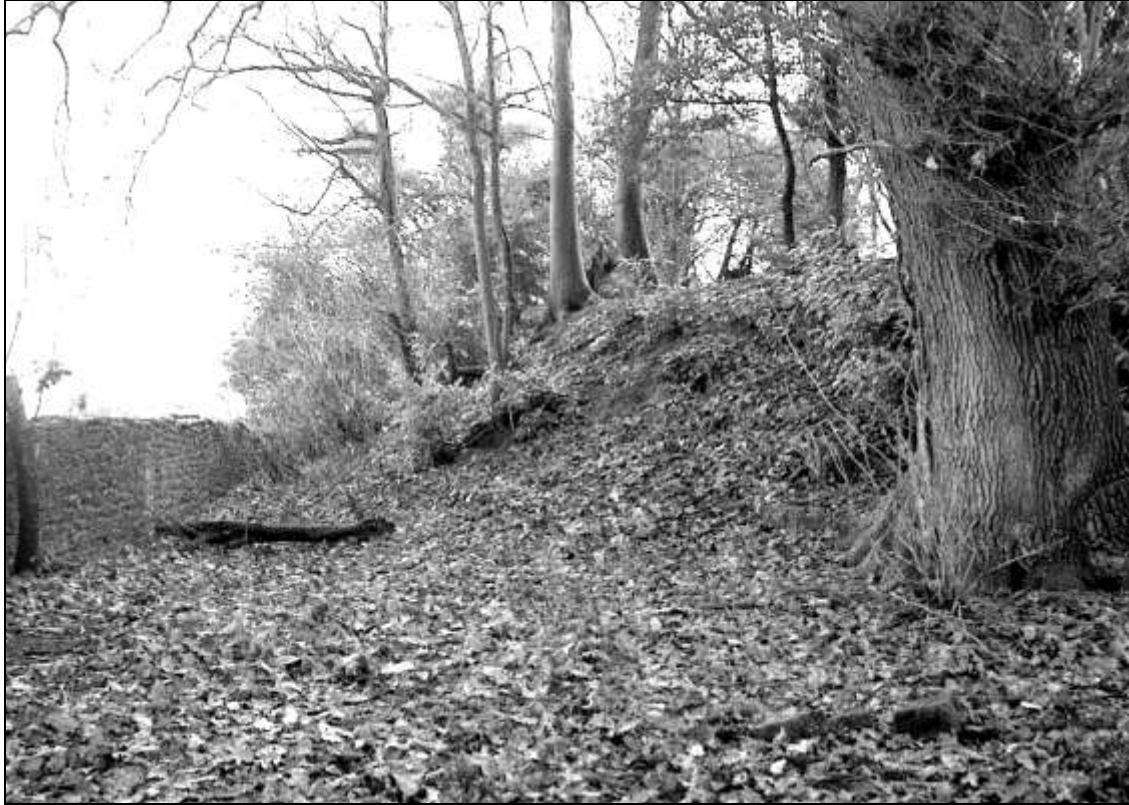
Figure 6 Mound above natural on NW side

*This is one of those sites that ought to be a castle if it isn't one, and the present evidence is thin on the ground. We have a large mound in a perfect position to form a motte castle controlling the area. Unfortunately garden landscaping over the last 200 – 300 years has altered the area around the mound to such an extent that it is difficult to come to any conclusions as to its original purpose.. Any evidence for a bailey area, which might be expected around a motte, would have been eliminated.*

*At present we have an impressive mound that seems to be a boss of rock made up and leveled with clay and soil. The sides appear to have been scarped but there is some slippage of soil, and some quarrying of the rock in one side of the mound.*

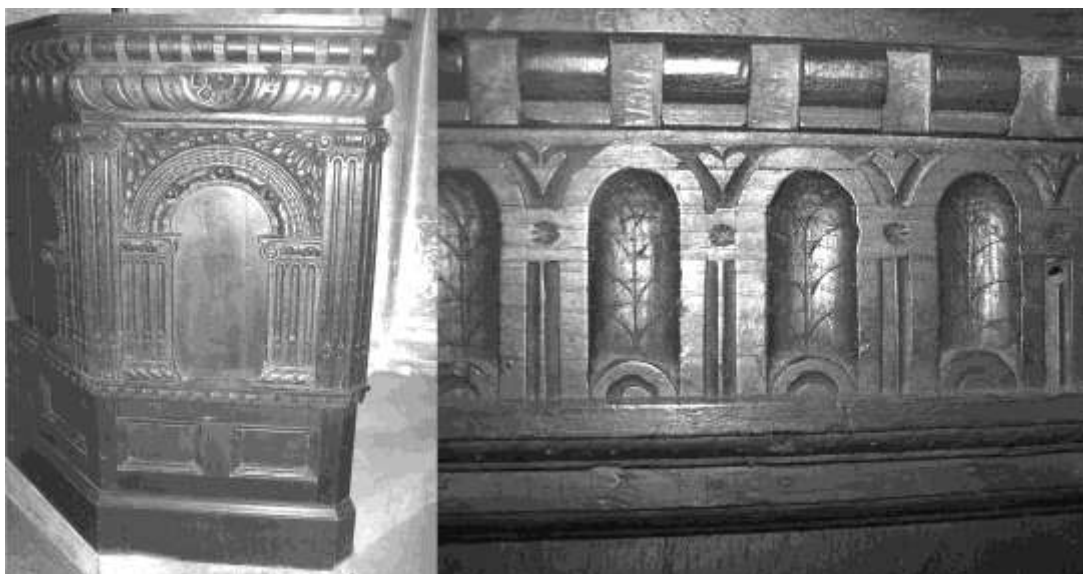
Figure 2 Panelling on Pulpit and screen

The fine Jacobean panelling was taken from the old Putley Court square pew in 1876, shown as 'the site of Riley's box pew'.

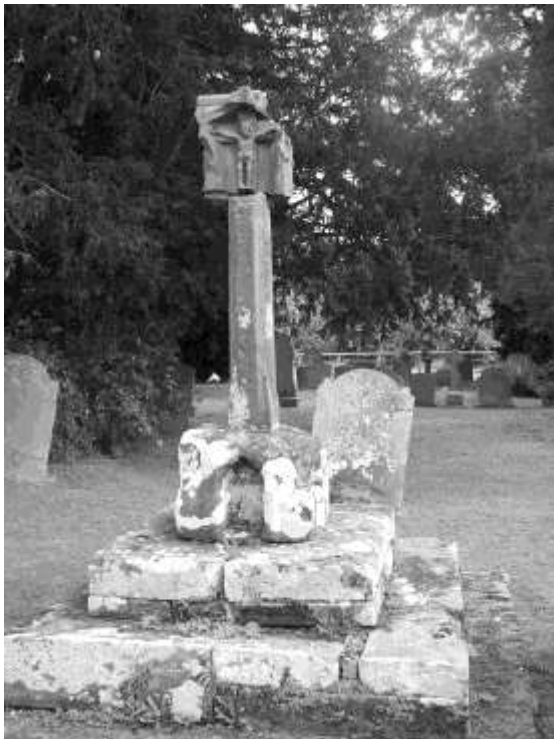
Figure 7 Churchyard cross

The churchyard cross [SMR 7463] is very interesting, with a niche in the base. On top of the original shaft is a [[get correct term] . The junction of the shaft and the top is rather awkward, and the stone is not the same – the carvings would hardly have survived so well if it was.

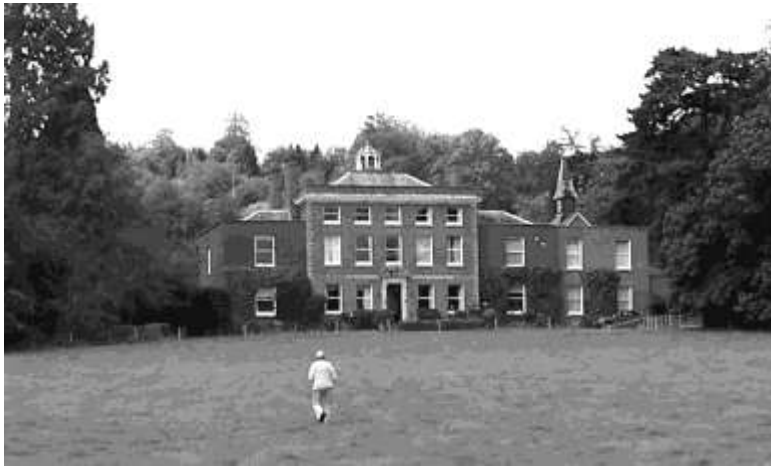
Figure 15 Putley Court front (R Lowe)

The central block of the Court was built in 1712 by Edmond Phillips. There are two flanking blocks which seem to have been built before the 1770 window tax. The front of the 1712 block appears to have been built possibly of mathematical tiles – certainly there is very white raised pointing which has been infilled with stucco painted red (RCHM). The side blocks seem to be built of an inferior yellowish brick which has been painted (maybe many times) to try to match it to the 1712 block. There is another later block to the right front, and between this and the 1712 block, but behind the front block is another block – this may have been a separate building. It was altered later, possibly in 1922 when bay windows were added at the back.

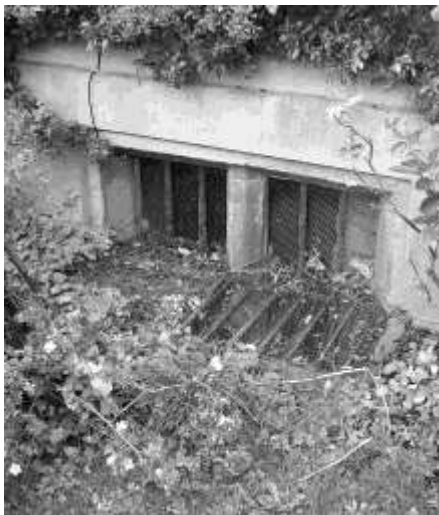
Figure 17 Exterior cellar window

There are 4 windows with apparently earlier stone window frames at the front of the house in the 1712 block. However, they must have been inserted in 1712 as they are embedded in the new plinth around this block. This is clear from the outside photo.

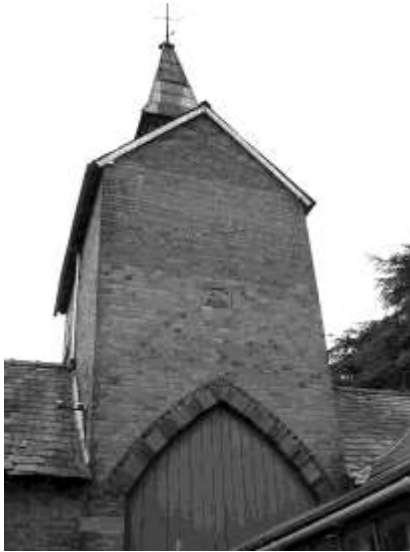
Figure 19 Stable tower

There is a very decorative stable block to the NE of the main Court building. It was built for the Riley family who bought the Court in 1872. The arched doorway under the tower is framed with contrasting red and grey bricks.

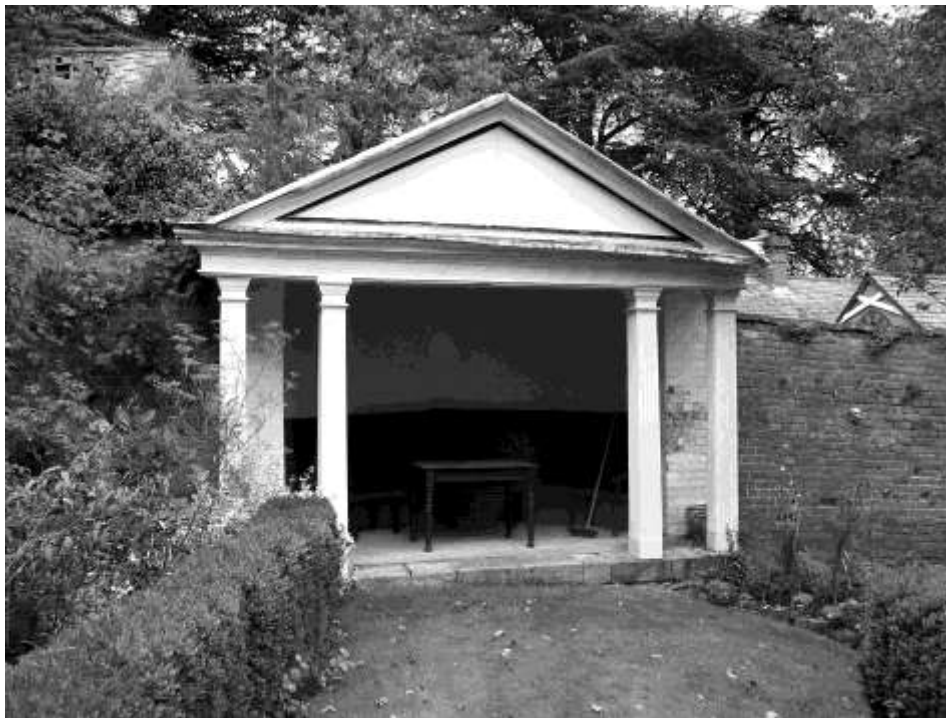
Figure 21 18th C Summer house

The gardens and landscape park around the Court **[SMR 31191]** are shown on the 1832 OS 1" map, but one of the features, a listed classical summerhouse may very well date to the 1712 building. The rear of the summerhouse is accommodated in a specially curved section of the straight garden wall, and on the garden side it is furnished with a built-in bench. The bench is currently painted a bright blue and the rest of the 'temple' white, with a blue band on the pediment. As the garden rises in terraces away from the house, the summer house has a good perspective south westwards over the gardens.

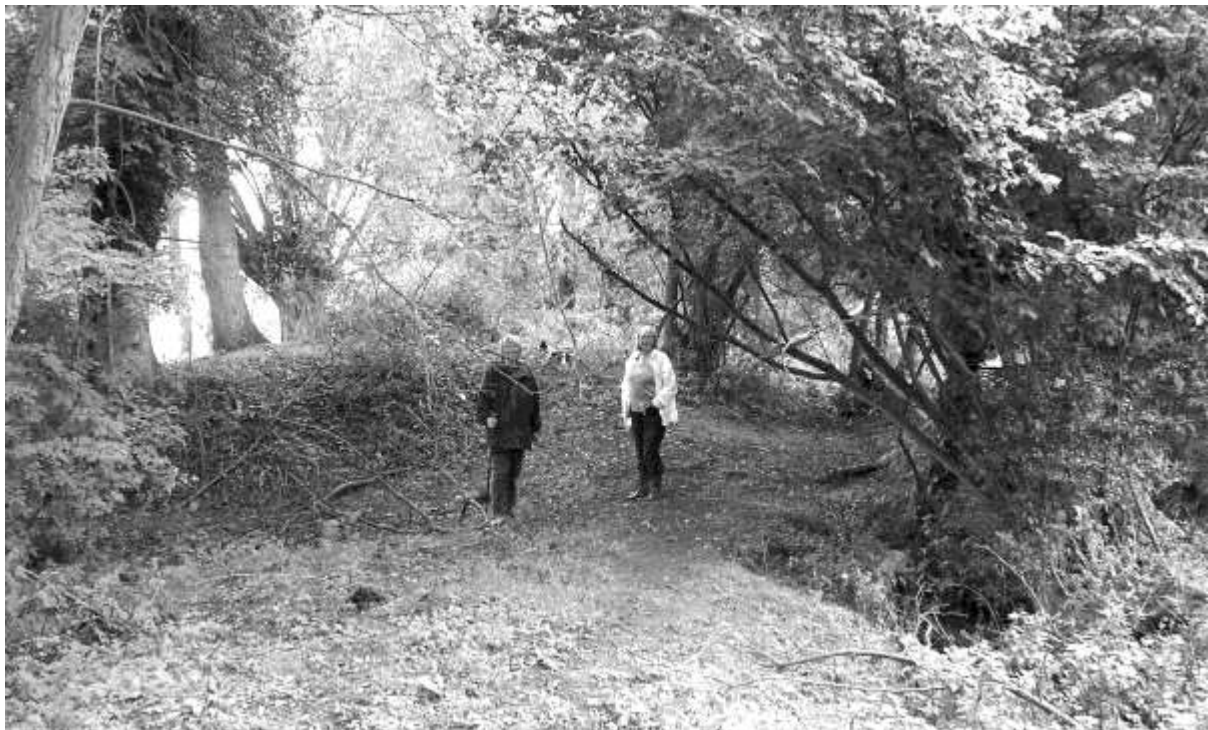
Figure 29 'Moated site'. Members are standing at the level of the building shown in the tithe map, with the 'island' itself behind. The stream runs in the channel to the right

Although there had been speculation that the site could be some sort of defended dwelling, its low lying nature would seem to make this unlikely. The stream is really rather slight, and could easily be dammed upstream. It could of course be a moated conigree, doubling as a mill pond it is called 'Island'

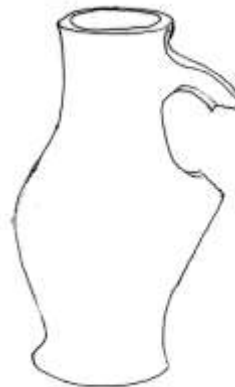
Figure 24 Typical jug in the ware

The material is terracotta, with a greyish core. It is clearly part of a strap handle, and in fact jugs form over 95% of the material for this ware. It has been found as far north as Richard's Castle; in Bredwardine, Lydney, Hampton Wafer and Gloucestershire S of the Severn, but our sample is the furthest E in Herefordshire. It has also been found at Grosmont, Skenfrith & White Castles. The fabric is found first in mid 13thC contexts, rising to a peak in the 14<sup>th</sup> C and is residual by the 16<sup>th</sup> C

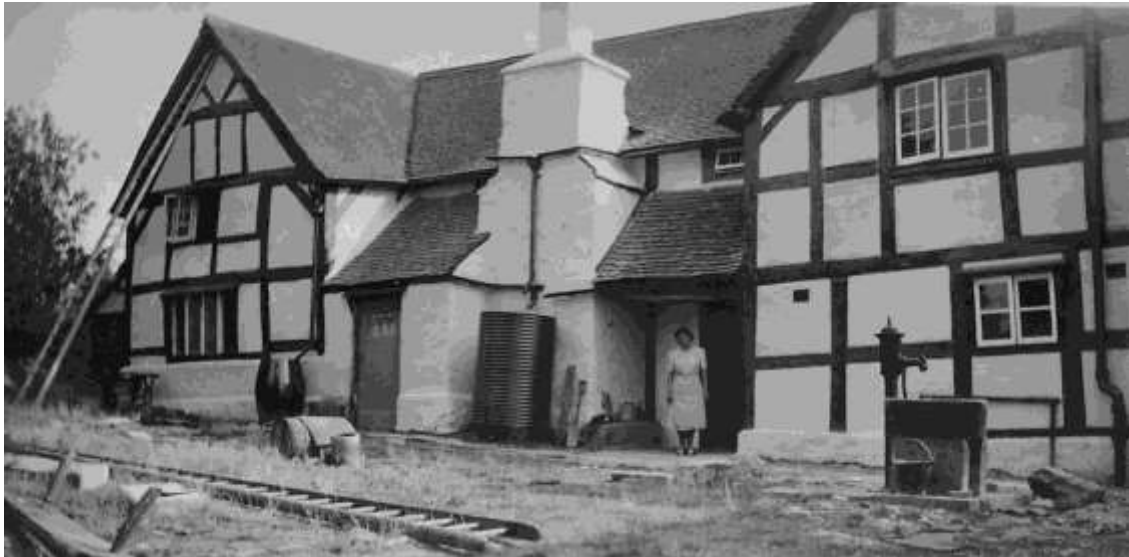
Figure 3 N front of farmhouse, photo probably 1950s

We were fortunate that one of our guests was somebody who had lived in the farm as a child in the 1950s, and we are grateful for the use of her photographs. The farmhouse has been extensively renovated, and in the process some later additions to the outside have been removed. For example, on the N front the 'porch' to the left of the chimney stack (see below) has been removed. This gave access to the dairy which at the date of the photo occupied the N half of the E cross-wing. A number of the timbers on this side of the E cross-wing were rotten and have been replaced. Also removed is the little pentice roof on the W side of the chimney.
