# HEREFORDSHIRE ARCHAEOLOGICAL NEWS

HAN 76      2005

WOOLHOPE CLUB  
ARCHAEOLOGICAL RESEARCH SECTION

## **Field Meeting to Whitchurch, Llangrove and Glynston Chapel by Roz Lowe**

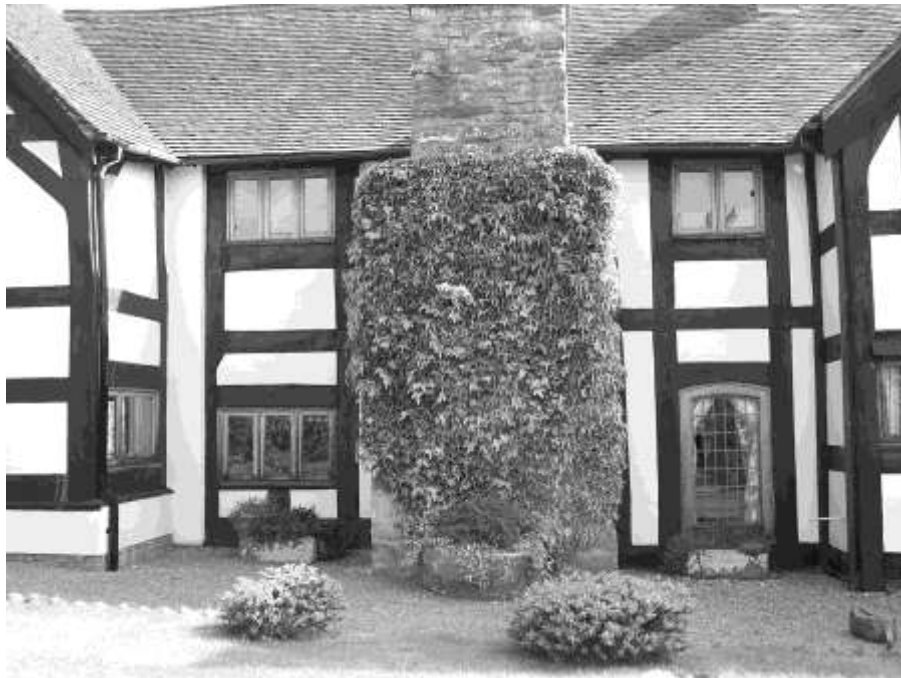
Figure 4 N facade with pentice and porch removed

We were fortunate that one of our guests was somebody who had lived in the farm as a child in the 1950s, and we are grateful for the use of her photographs. The farmhouse has been extensively renovated, and in the process some later additions to the outside have been removed. For example, on the N front the 'porch' to the left of the chimney stack (see below) has been removed. This gave access to the dairy which at the date of the photo occupied the N half of the E cross-wing. A number of the timbers on this side of the E cross-wing were rotten and have been replaced. Also removed is the little pentice roof on the W side of the chimney.

The RCHM consider that the original entrance to the cross-passage was a door to the right of the chimney, but if this was so it would be very close to the large hearth inside.

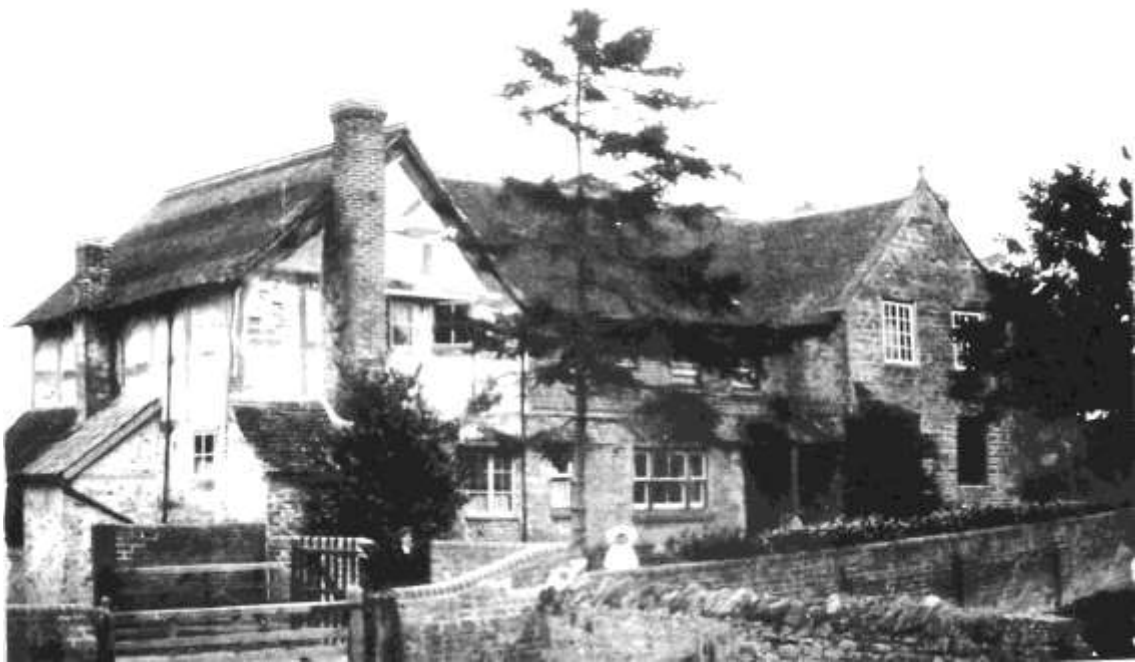
Figure 5 S front and W side of farmhouse, photo probably late 19C or early 20C

The series of photos (figures 5 to 7) of the S façade span about 100 years. The original stone facing of the central block and the E cross-wing was rendered by the 1950s, and the timber-framed W cross-wing was made a rather startling black & white. The earliest photo shows the E cross-wing with shutters on the lower windows, so probably this room backing on to the dairy was a service room too. All the windows in the central section and the E cross-wing now conform to those in the E wing originally.

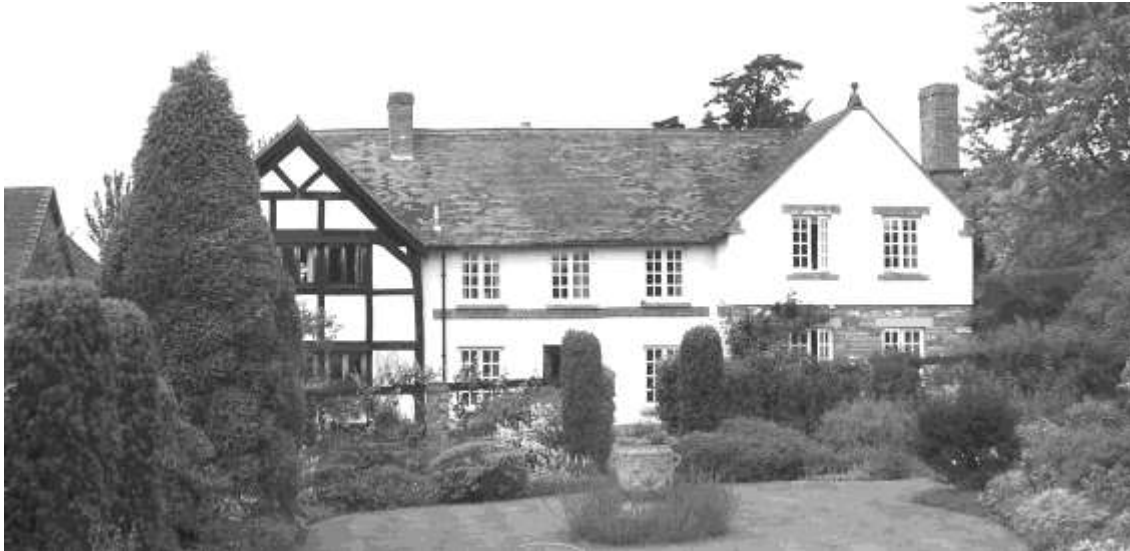
Figure 31 S front today

A lean-to on the E end of the E cross-wing has gone; a chimney and lean-to on the S of the W cross-wing has gone, and the lean-to on the W of the W cross-wing has been replaced by a porch. This porch is built with old reclaimed timbers, and the entrance door in this porch is also reclaimed. The RCHM comments of some old panelling in the house, but this had disappeared by the time the current owners arrived. A new chimney has been inserted in the E wall of the W cross-wing.

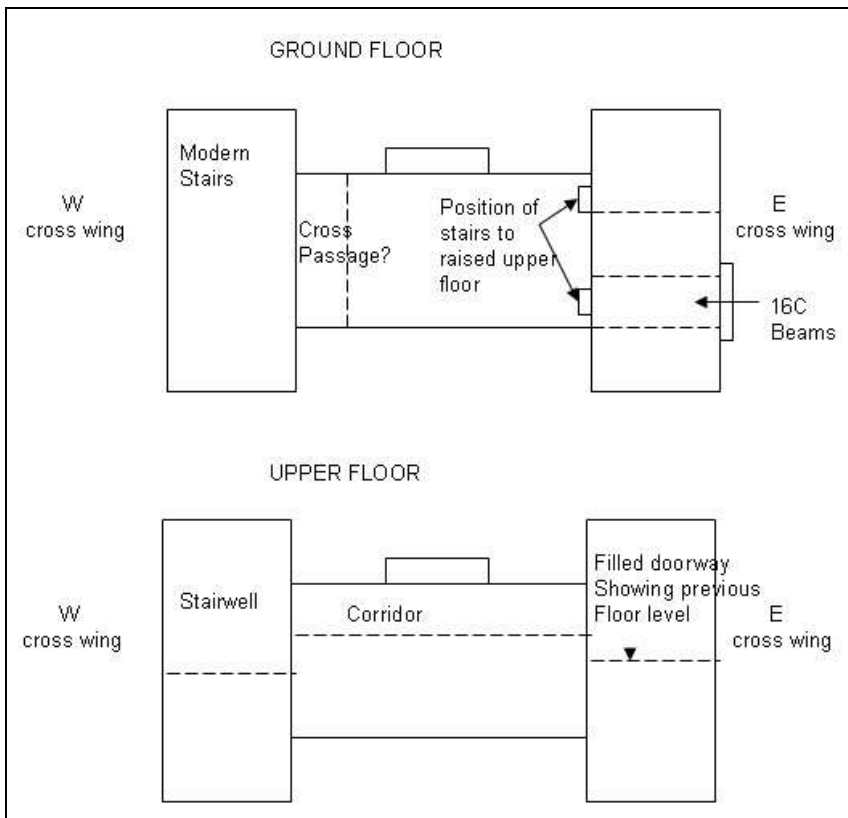
Figure 32 Outline house plan - not to scale

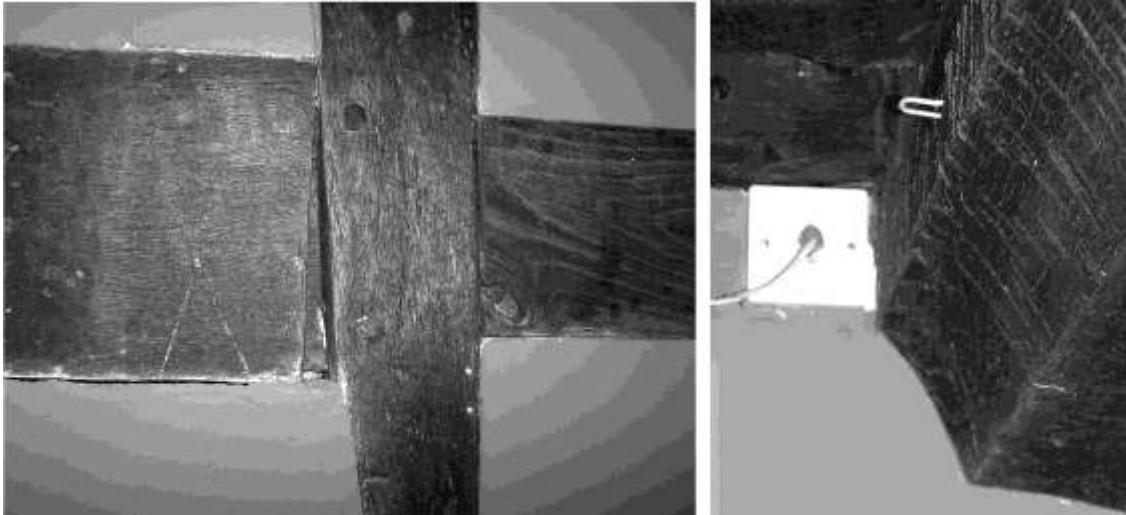
Figure 9 carpenter's mark on W wall of central block, and chamfer on E-W beam, both downstairs

Jim has dated this block to the Civil War period. Upstairs, a corridor now leads from the modern staircase in the W wing to the E wing. There is a series of carpenter's marks on the timbers at the E end – see fig. below.

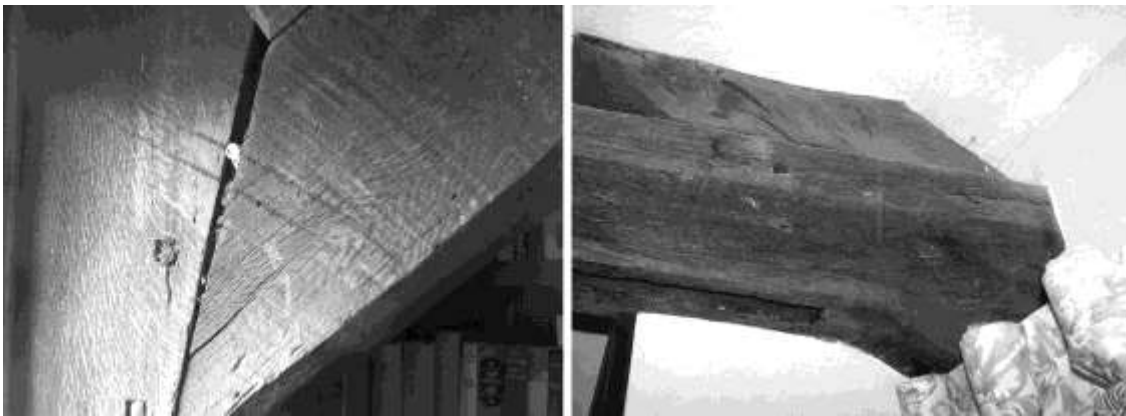
Figure 10 carpenter's marks at E end of central block

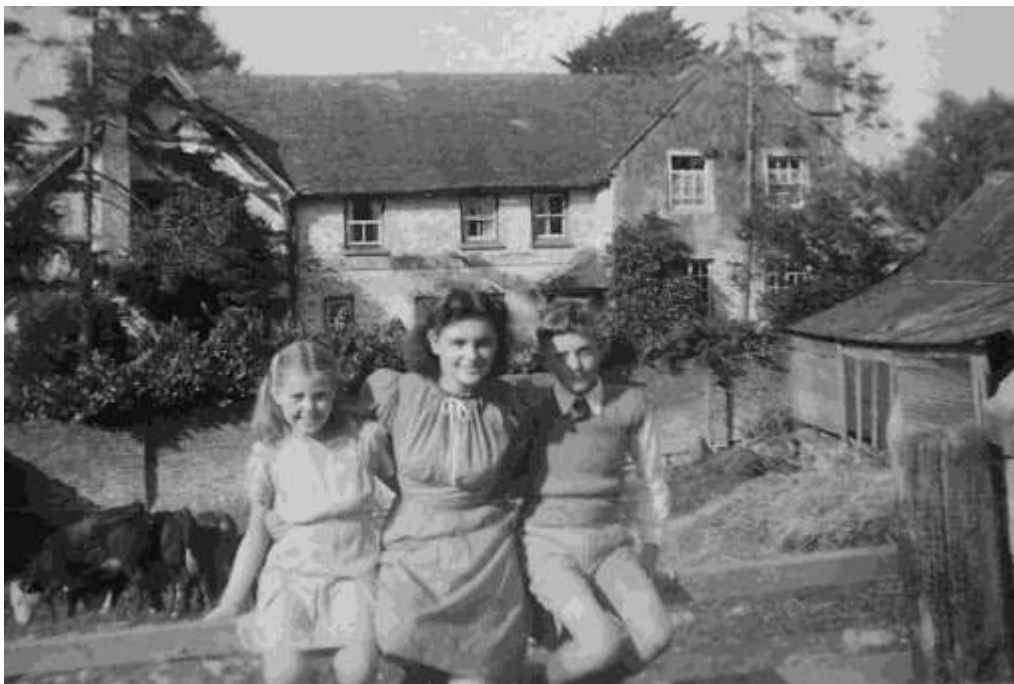
Figure 14 View of S of house with farmyard

This photo from the 1950s shows the animal houses (building 6a) which have since gone. The S portion of 6, 6b, is still in existence

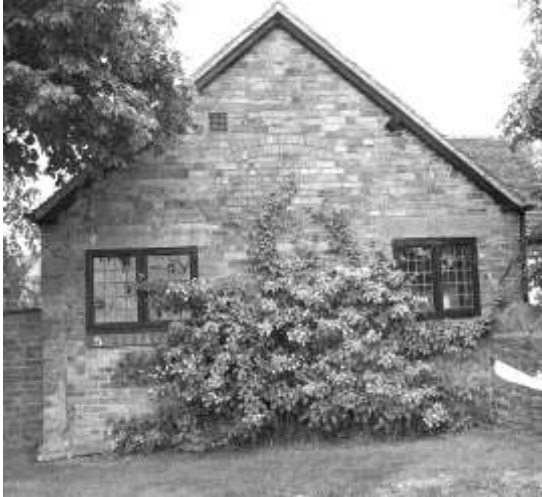
Figure 15 Building 2 from W

Building 2 has been largely, if not totally rebuilt since the tithe map. The W end abuts the road, and it would appear that there was originally a large door between the two inserted windows. This would seem to indicate a stable.

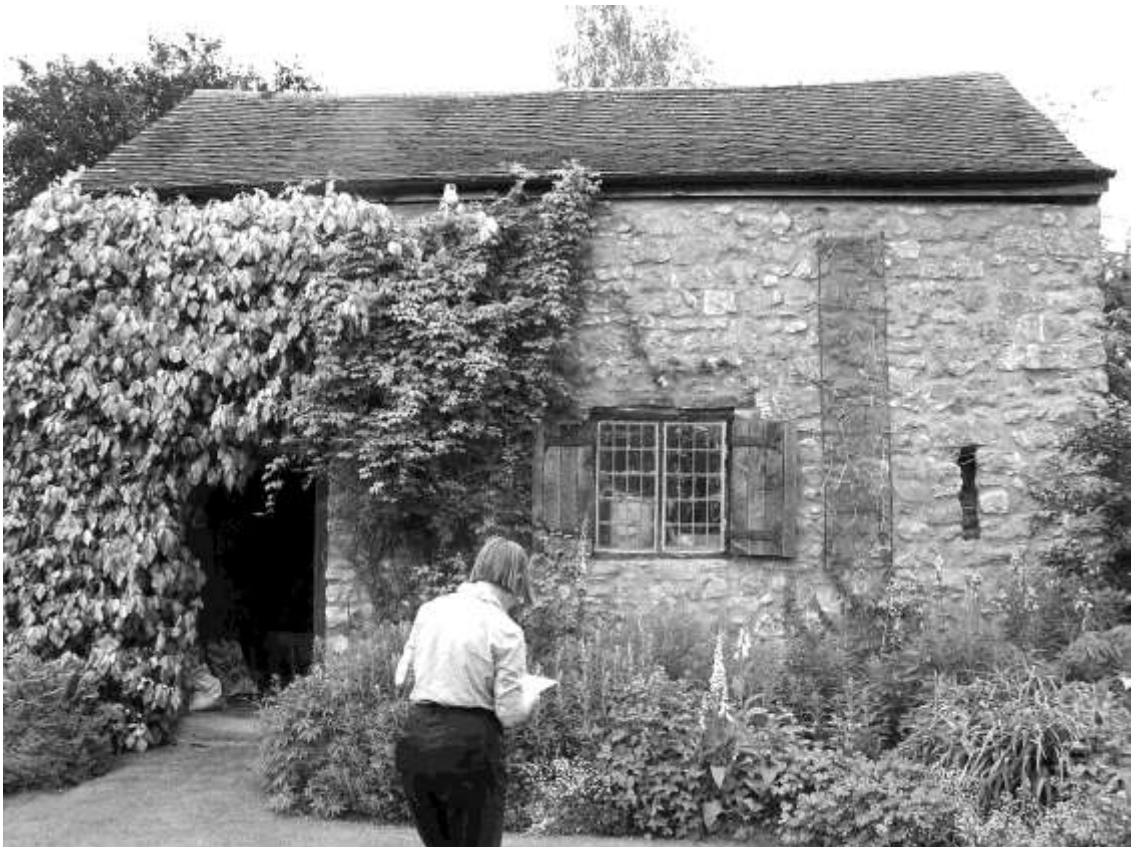
Figure 15 W facade of building 6a

Building 6a has an upper storey accessed by a door on the S face. It would seem that the building was earlier a barn, from the ventilation slot remaining. It may have been converted to a stable when the brick barn (building 10) was built. The floor is mainly cobbled, with an inserted brick strip presumably to aid drainage. The S wall has a piece of timber from a timber framed building embedded into it, showing the peg holes. All the farm buildings are roofed with brown tiles.

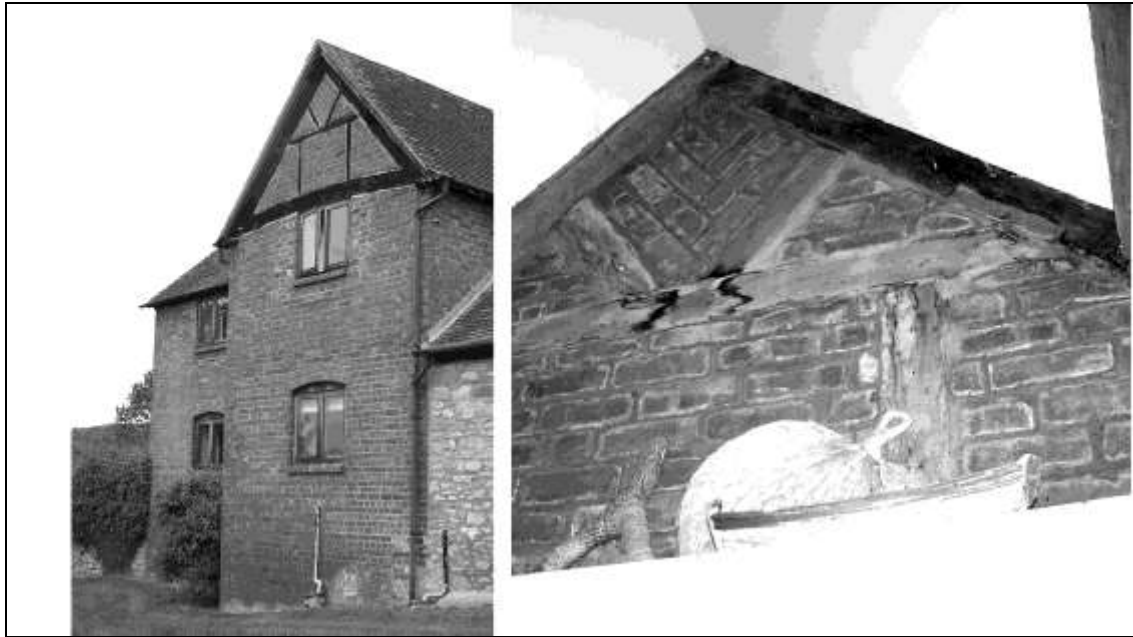
The W gable also shows timber framing, and in this case there has been some re-use of older timbers – see next figure.

Figure 17 W wall of building 8

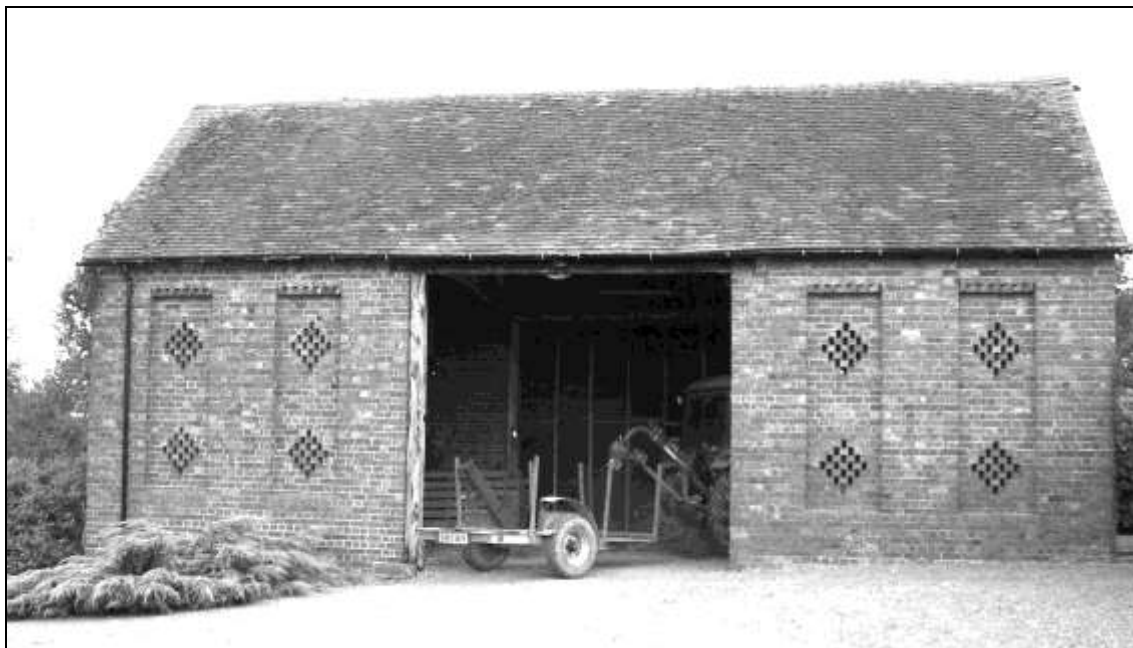
Figure 18 Building 10

After the time of the tithe map, a handsome threshing barn was added – building 10.

Although beautifully built of brick, economy has been practised in the re-use of older timbers for the roof timbers – see next figure. The detail shows the punched 19C carpenter's marks made when the timber was re-used.

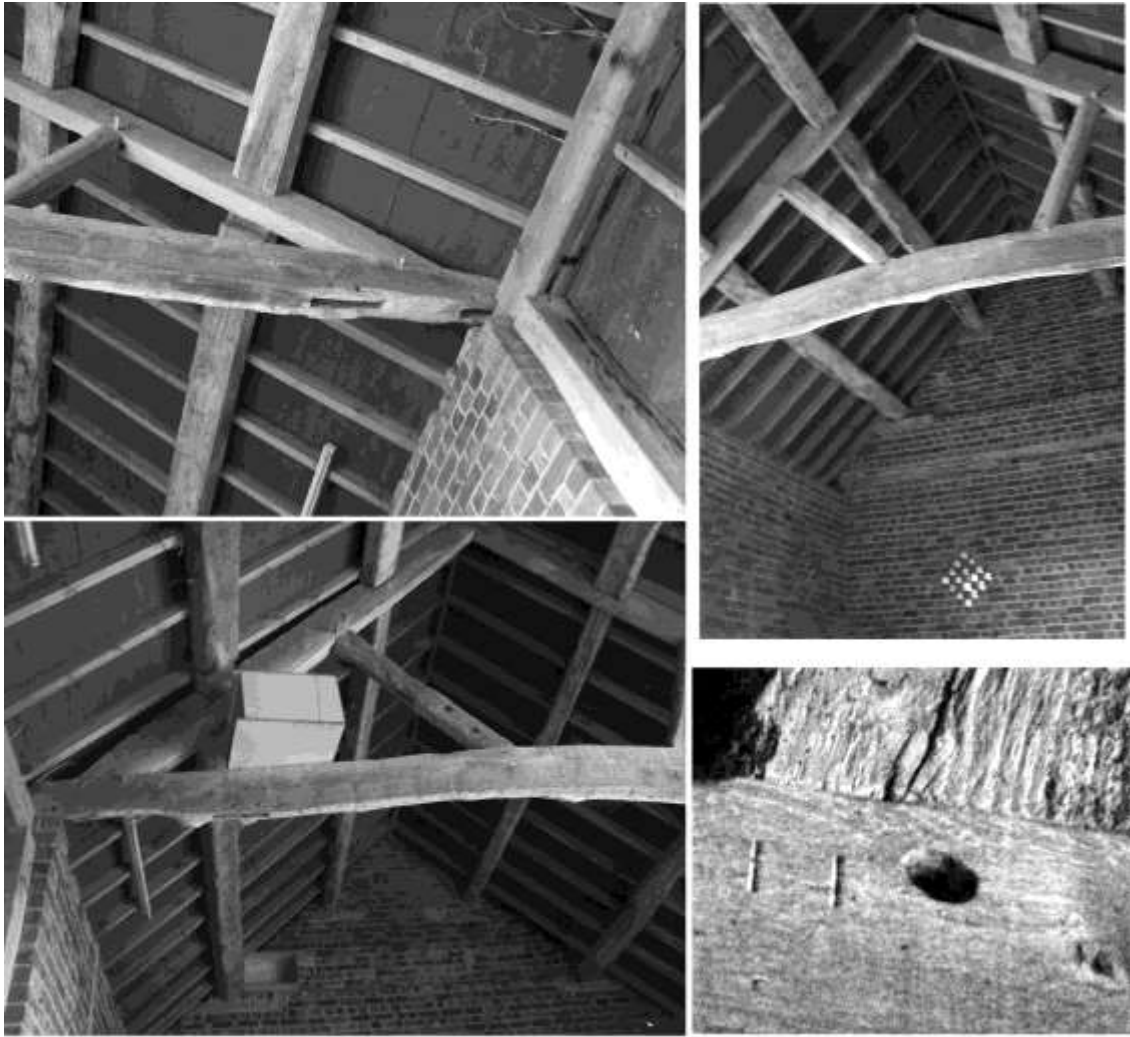
Figure 19 Building 10 roof timbers
