# **HEREFORDSHIRE ARCHAEOLOGICAL NEWS**

**HAN 81      2010**

**WOOLHOPE CLUB  
ARCHAEOLOGICAL RESEARCH SECTION**

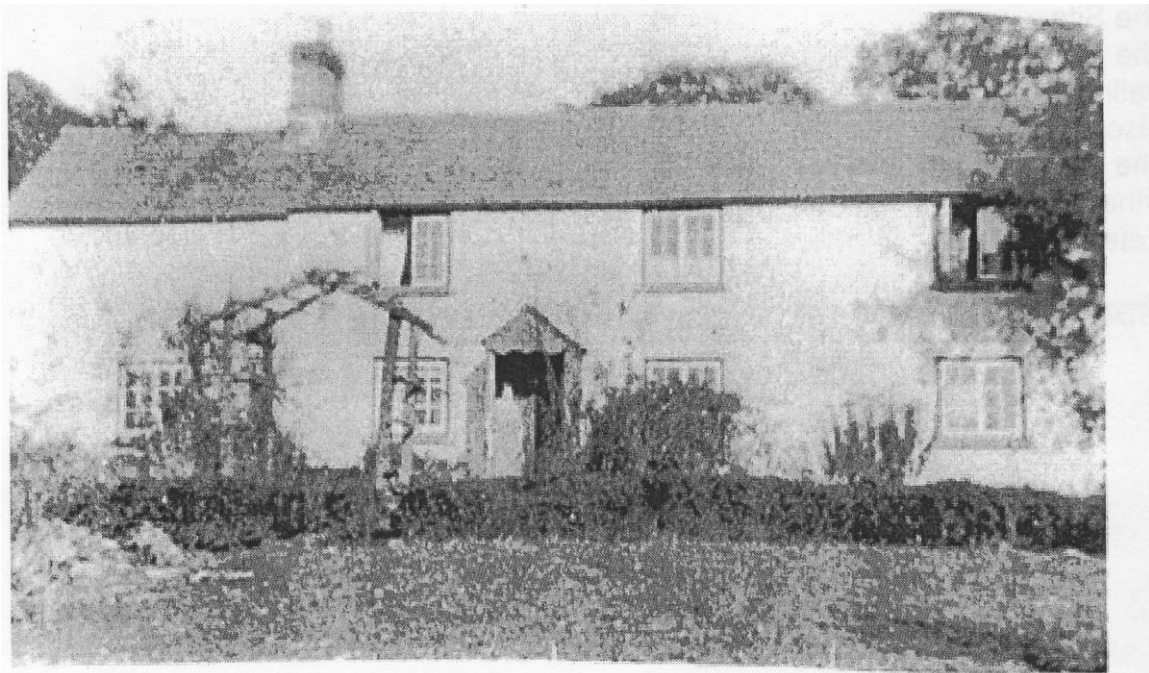
**Figure 1: Photo of Lea Bailey Lodge provided by E M Adams; son of the last Forestry worker to tenant the lodge**

The photograph (Figure 1) was taken by James Adams (probably in the 1920s) who lived there as a forestry employee from about 1897 to 1931 before retiring to The Langetts, Hawthorn Hill, Drybrook. He died in 1945 and is buried in Hope Mansell graveyard.<sup>2</sup> From this photograph the lodge appeared to be a modest two storey stone cottage with slate roof in four bays and very much in the local vernacular style.

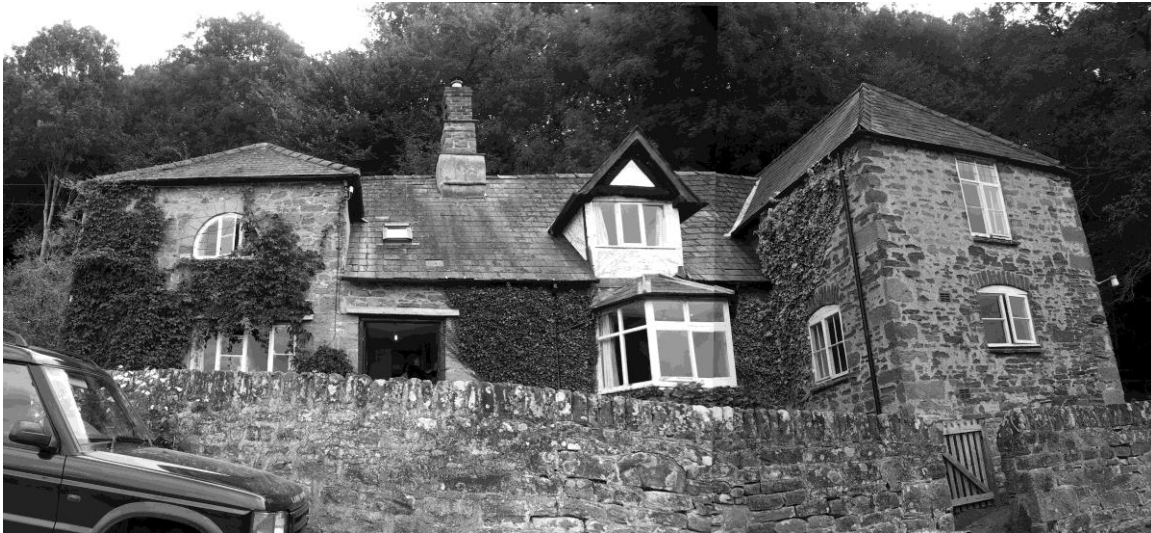
Figure 2. The front of Mainoaks house. Merged photo

It is extraordinarily difficult to photograph the front of the house, as there is a wall close in front of it, and the yard in front of that drops away. The house faces the Wye, and behind the house Coppet Hill rises steeply. From the front the house gives little indication of age, but there is a timber-framed wing at the back, though not of such age as the middle section which housed an open hall dated as 15th century.

Note the very wide front door which may have been the original cross-passage. However, the passage it opens onto now separates the hall from a later cross-wing.

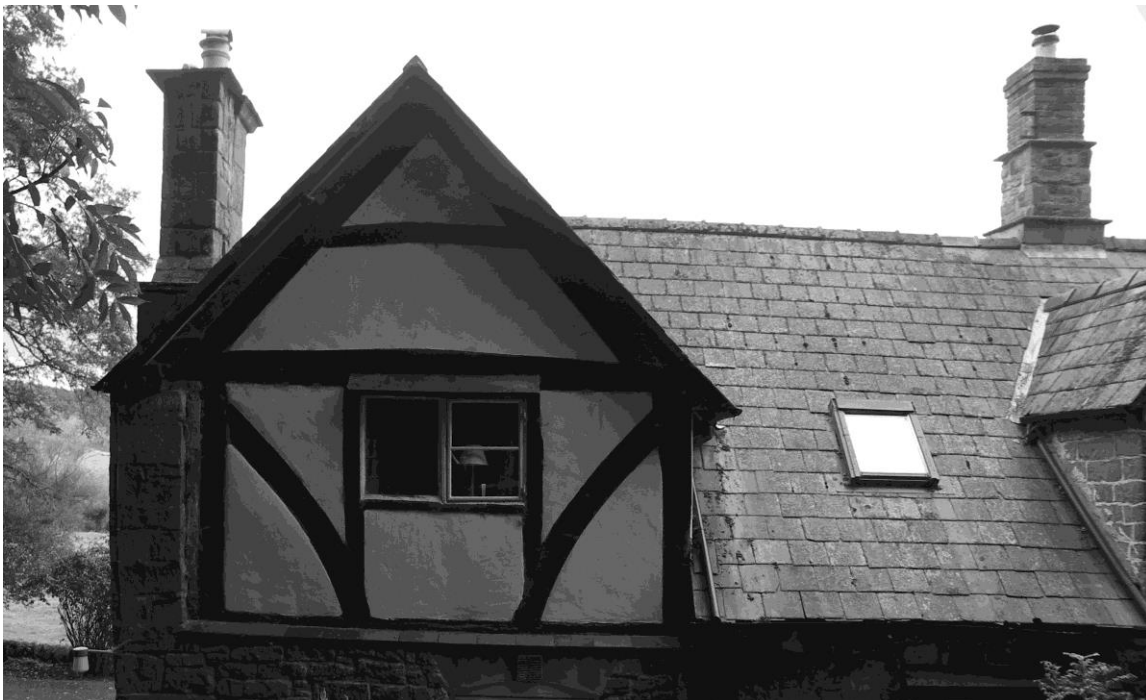
Figure 3. Exposed timber-framing at rear of farmhouse

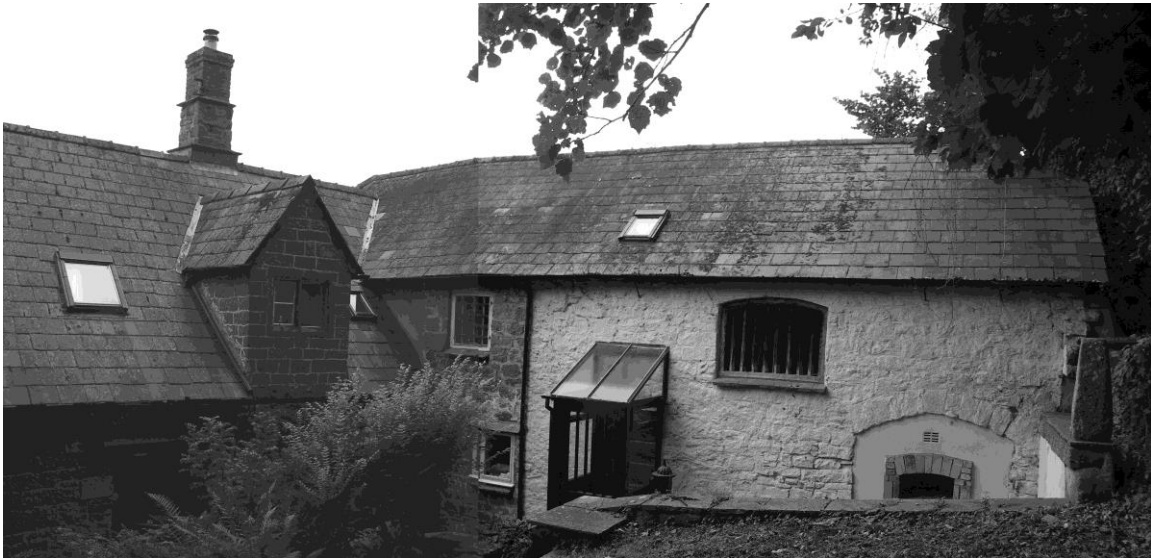
Figure 4. Rear of farmhouse looking NE. The NE wing may have been a cider house or similar at one time, or animal housing. Merged photo

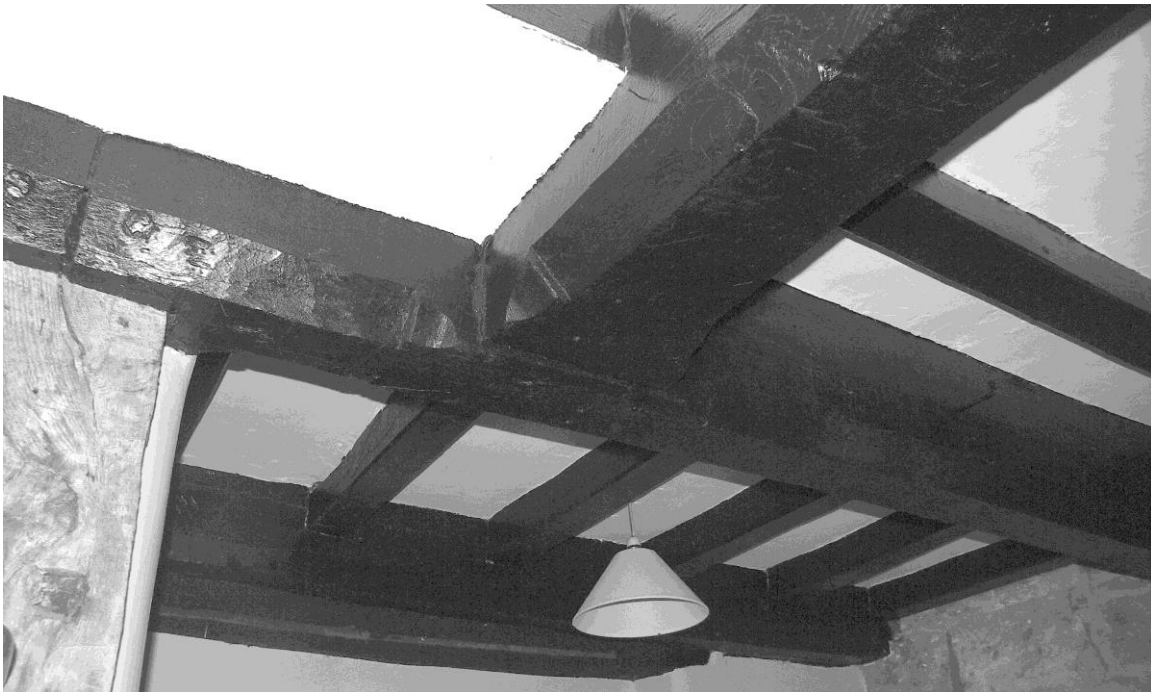
Figure 5. Inserted ceiling in S cross-wing of farmhouse

Inside the S cross-wing of the farmhouse, the bottom of the crucks are clearly visible, but the hall has been ceiled, and a massively beamed floor inserted.

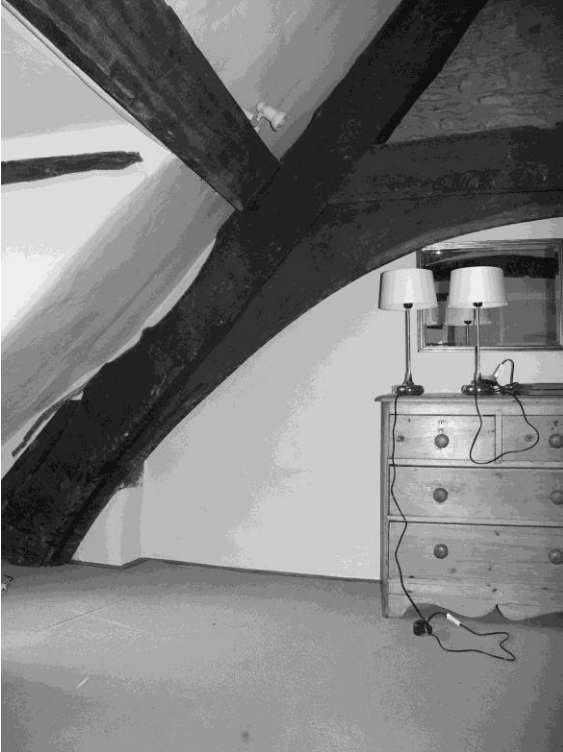
Figure 6. Open cruck in first-storey bedroom in farmhouse, W wall.

A stairway was inserted in the late 17th century at the S end of the S cross-wing. Upstairs, the open crucks are visible in one of the bedrooms. The inserted chimney stack is visible in Fig. 7. If any boss had existed it has been lost.

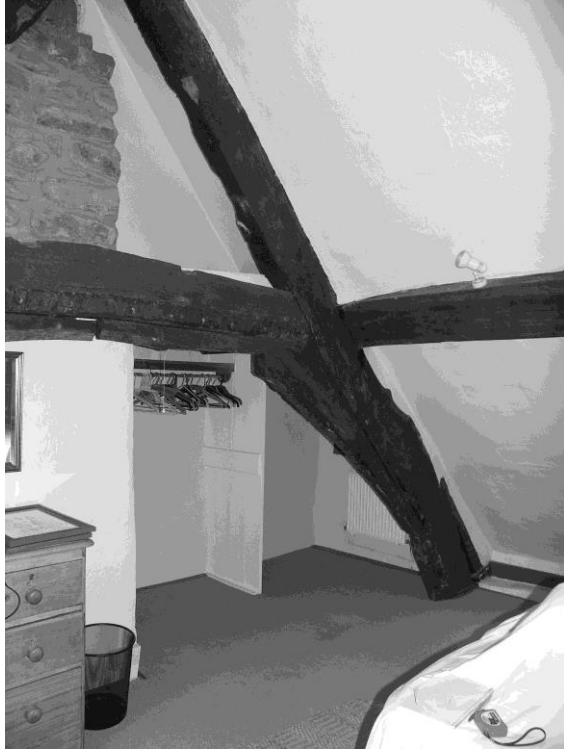
Figure 7 Open cruck in first-storey bedroom in farmhouse, E wall.

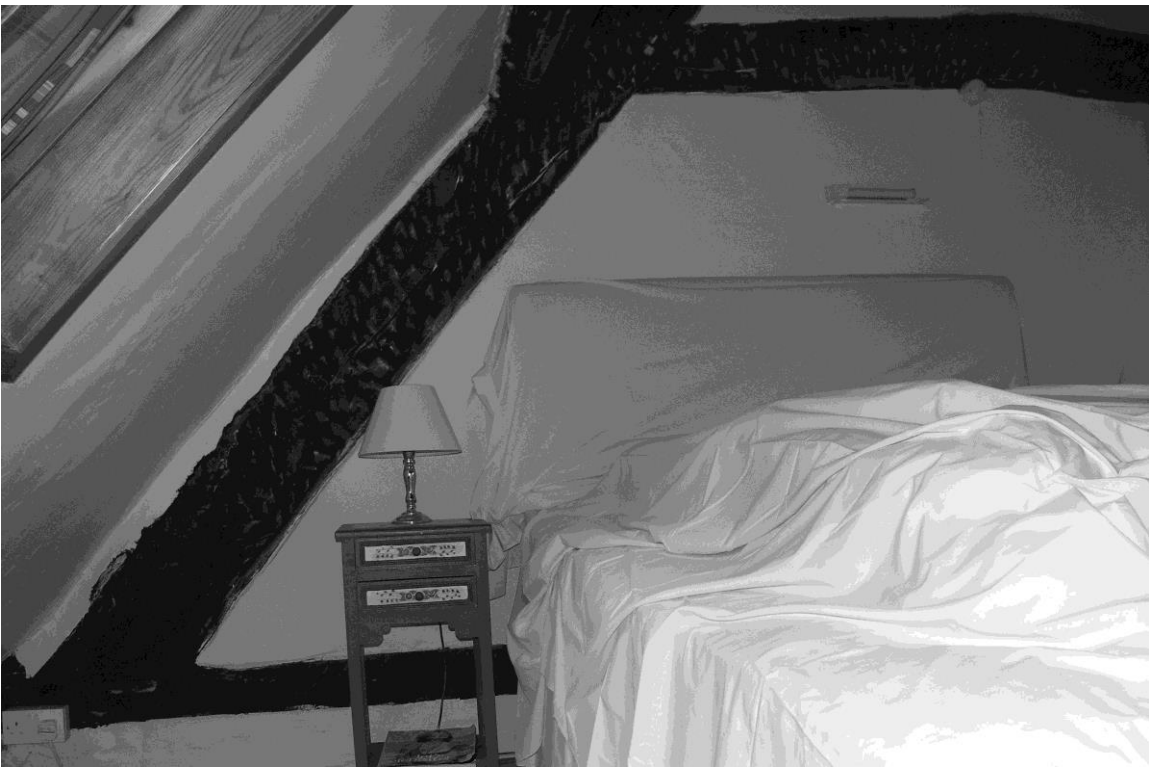
Figure 8. Opposite crucks above, wall next to the cross-wing at the S of the farmhouse

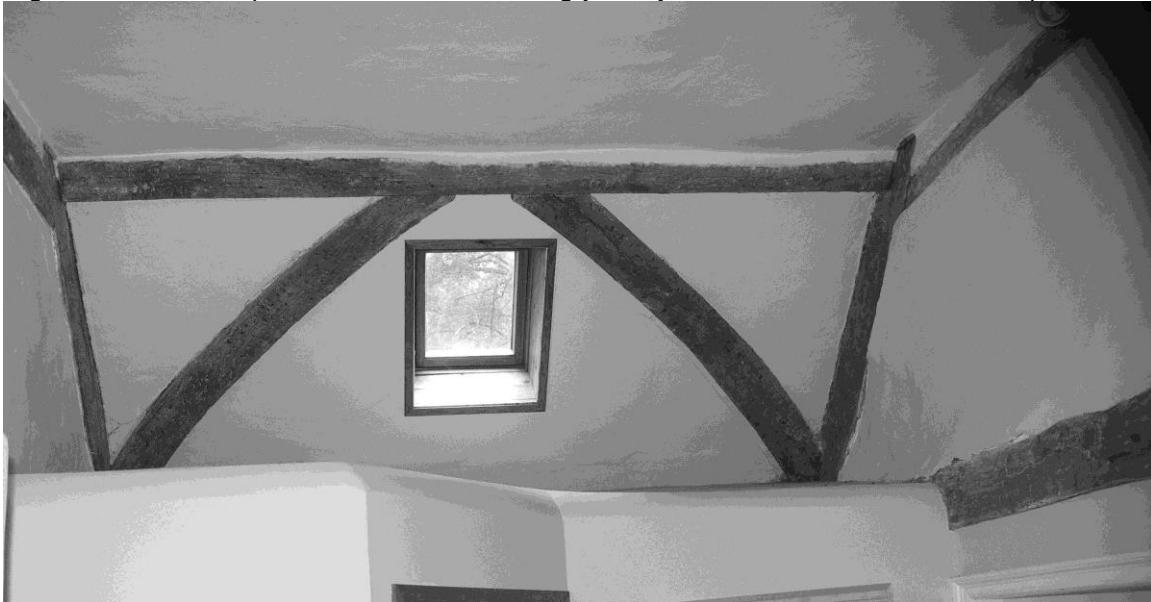
Figure 10. The middle bay of the S cross-wing of the farmhouse, S-facing roof timbers. The middle bay is a landing with an open-topped bathroom area.

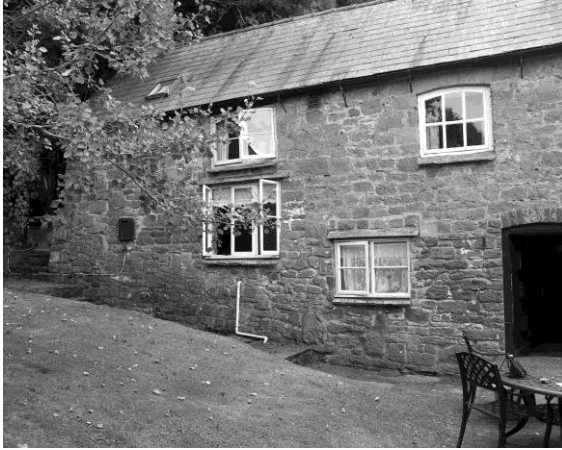
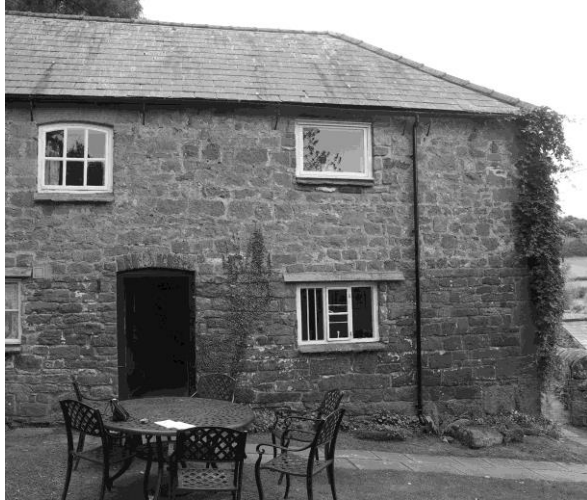
Figure 11. N aspect of farmhouse, left  
Figure 12. N aspect of farmhouse, right

The northern bay of the farmhouse is also cased in stone on the north aspect (Figs. 11, 12). The outside does not lead one to expect the substantial beams upstairs, on the E end of this cross-wing. A passage has been made on the S side to serve the bedrooms.

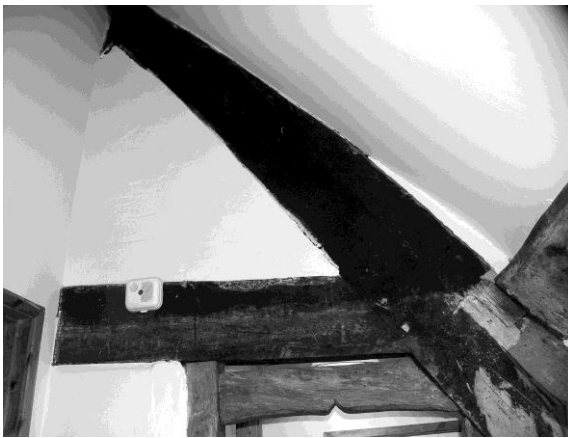
Figure 13. Cruck in inserted upstairs passage. the door head is modern  
The re-used timber in the E gable-end (not visible outside) may have come from an earlier building.

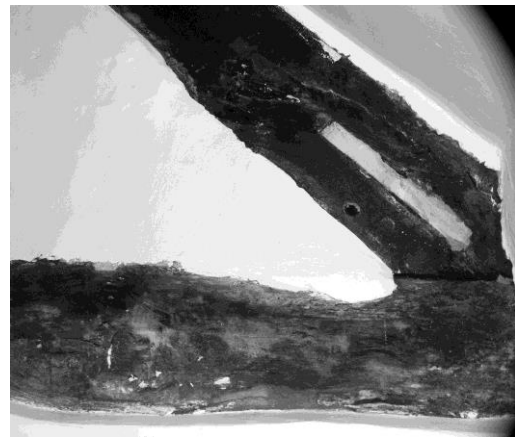
Figure 14. Re-used timbers in E wall of N cross-wing

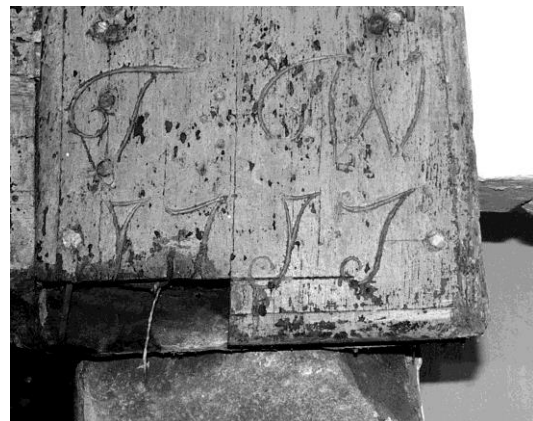
Downstairs in this N cross-wing, the floor-level at the E end is substantially higher than the W end, again raising the suspicion that the E end was once a separate building. The kitchen lies at the E end, and contains a massive stone fireplace. To one side there is a stone opening for a bread oven, and below it a hole for the bread oven fire. On the right hand side of the massive wooden lintel over the kitchen fireplace there is an engraved inscription (Figure 15 right):

**T W**

**1717**

From some privately-owned documents I have catalogued, William Weare & Eleanor Tovey married in 1679. Their joint estate included Mainoaks and was divided into 4 parts for their 4 sons, but Thomas Weare, one of the sons, bought back the quarters from the other 3 in 1714 and 1721. In February 1721/2 Thomas Weare of Goodrich married Elizabeth Bayse at Churcham. Presumably it is this Thomas Weare whose name is on the lintel. He was the father of William Weare the bankrupt.

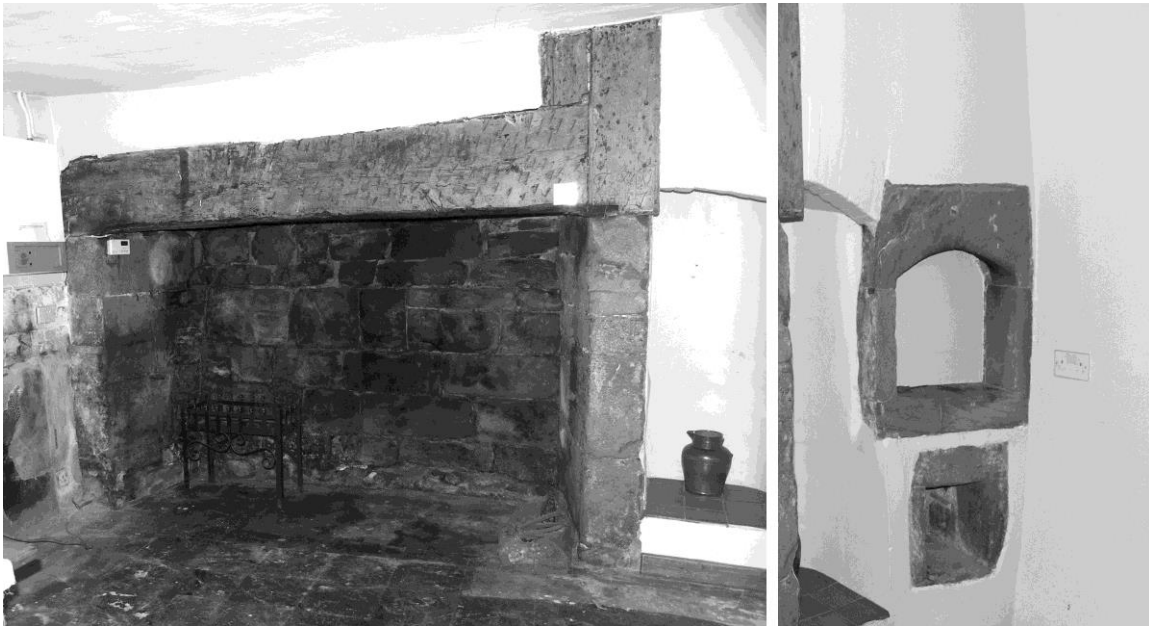
Figure 16. Kitchen fireplace and to the right the apertures for the bread oven and fire.

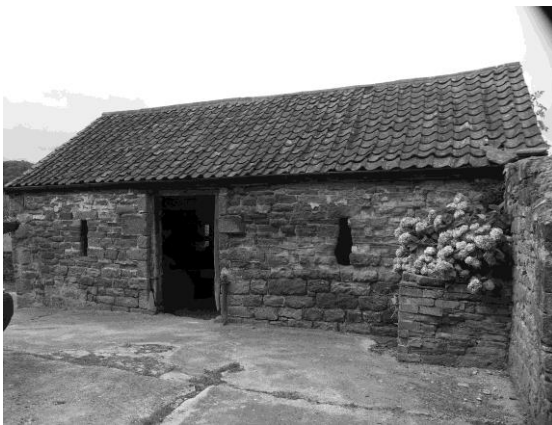
Figure 17. Cider house

In front of the farmhouse is a cider house containing the cider mill and press.

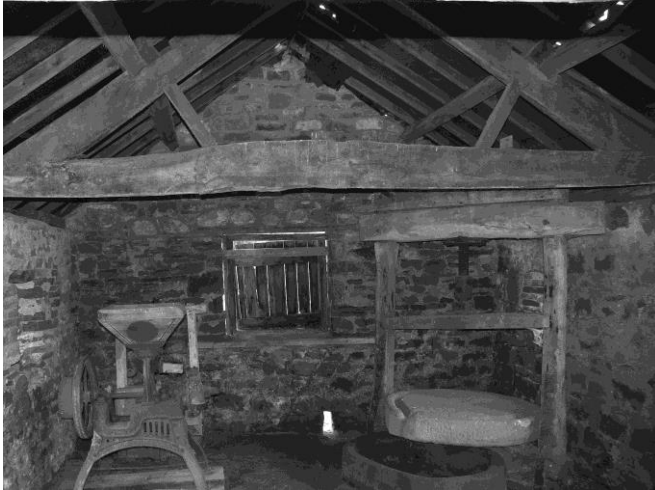
Figure 19 (above). Cider press and cutter

The cider mill was clearly horse-driven as can be seen from shaped beam. The uprights of the cider press have burn marks from taper sticks which have been knocked into the wood. The circular stone used in the press is very similar in shape to one in my house, and the tank is made of the same sandstone conglomerate found on Coppet Hill.

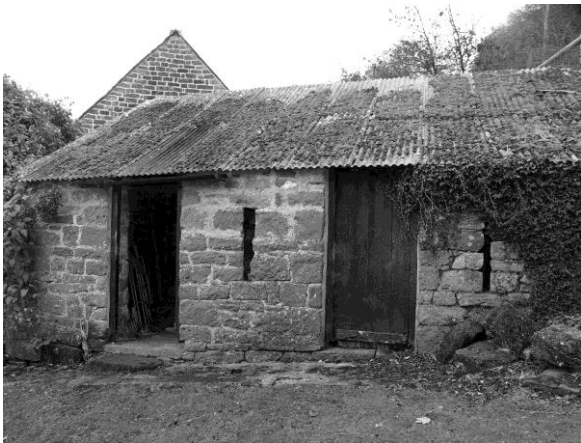
Figure 21. Small barn to N of house

Immediately to the north of the main house is a small barn, Fig. 21. To the north of that is a complex of 3 holiday cottages, apparently made from two original buildings. The upstairs room in the 'Malt House' has some cruck beams. The RCHM considers that this part of the complex of buildings is a 17th-century extension to the south of a 16th-century barn.

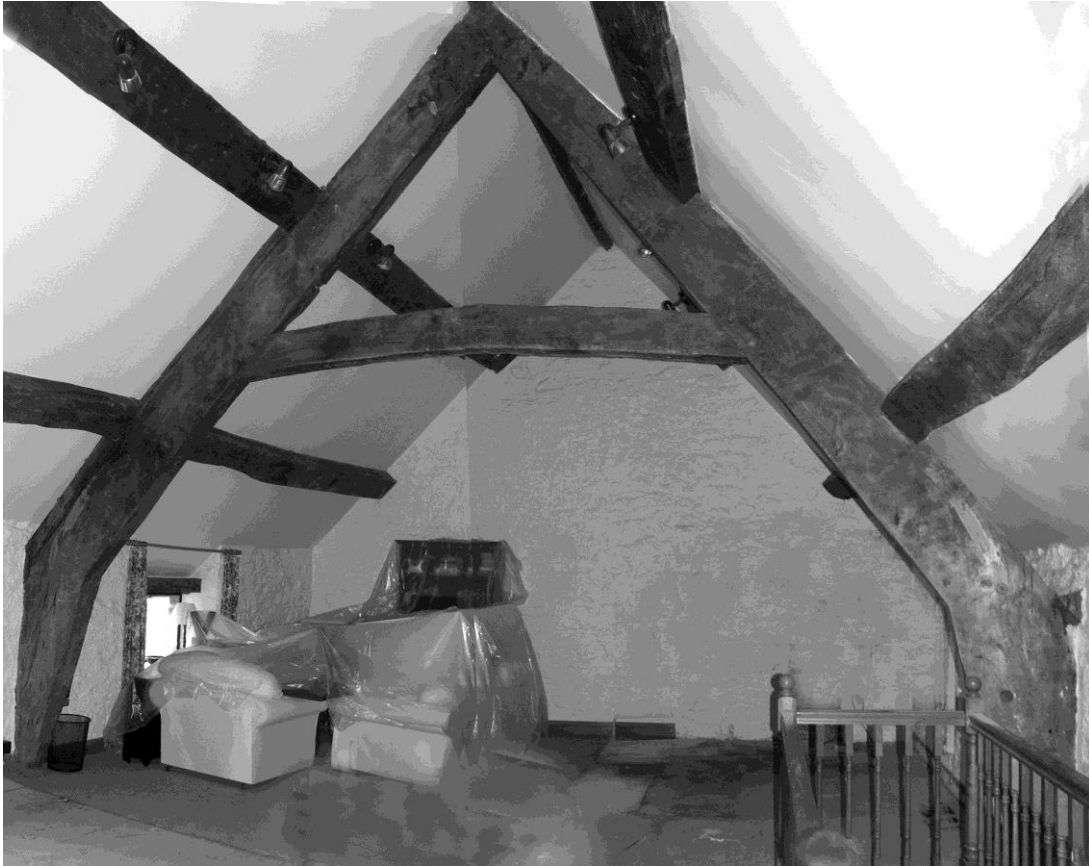
Figure 23. The beams in the malthouse. Two photographs were merged because of the difficulties of including both crucks in one shot.

The beams are workmanlike and suited to an outbuilding rather than a house (Fig 23). The ground floor is rather a puzzle, because it has been divided into two at about the location of the crucks, though now the partition is removed. The southern section has stone corbels on the western wall, but there are no beams running east-west for them to support, though there is a massive central beam running north south. The northern section has a massive beam running east-west, but it is inserted in the western wall very close to one of the stone corbels.

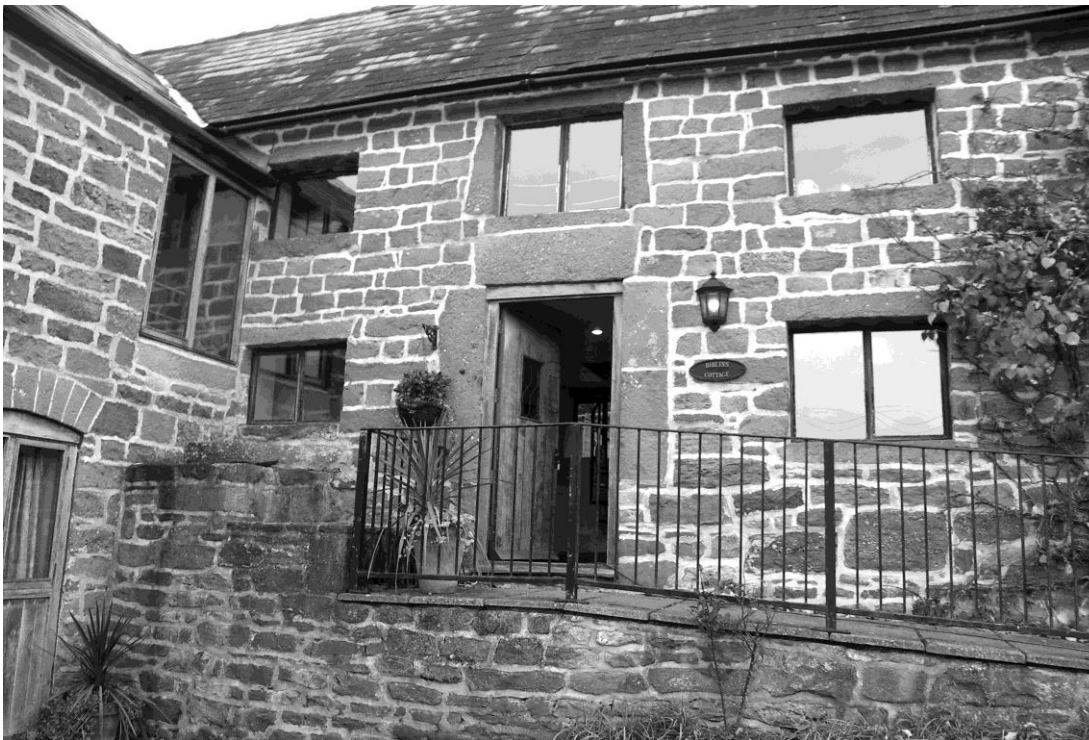
Figure 24. Front (W) of Biblins Cottage

The building attached to the Malthouse to the north, 'Biblin's Cottage', was quite clearly a barn, as the typical slits (RCHM - looplights) are visible at the rear (E) on the upper storey. However, the RCHM surveyors noted the monolithic doorhead on their visit in the late 1920s, and also that there were blocked windows and those not blocked had wooden mullions. So the lower windows at the rear may have been there then.

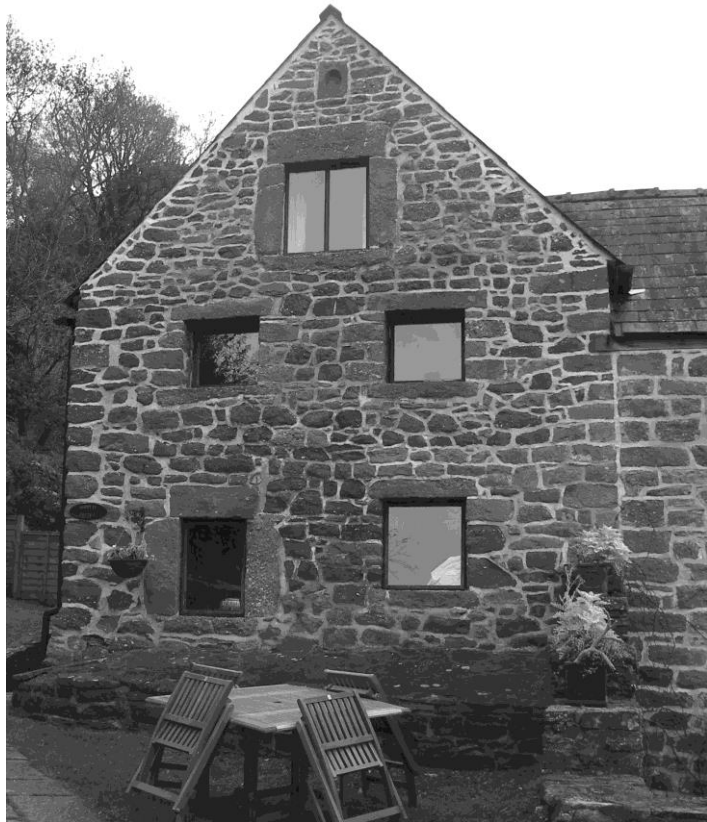
Figure 25. N gable of Biblin's Cottage

The survey does not mention the building attached to Biblin's Cottage on the right (W) in Fig. 25 (Huntsham Cottage).

However, the stone used in the construction is good quality and it is well built. Presumably the upstairs was used as a granary or store as there are steps to it, shown in Fig. 24, unless these are the remnants of steps to an entrance to the upper floor of Biblin's Cottage, which would explain the owl hole for a granary.

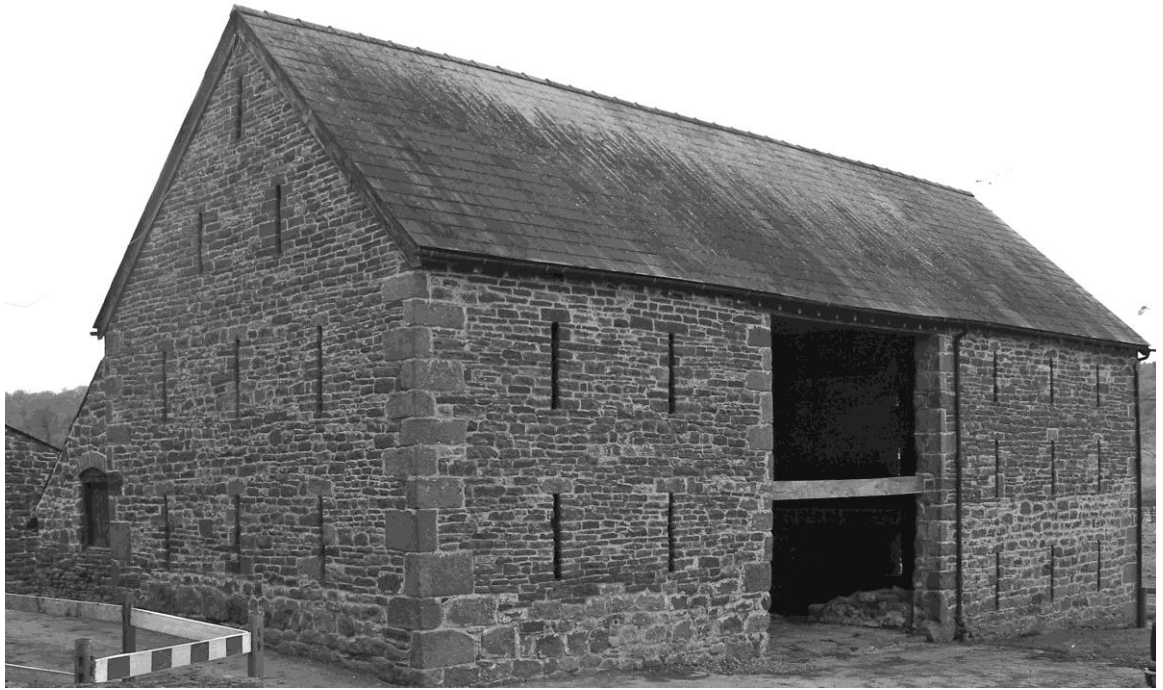
Figure 26. Threshing barn

The threshing barn was gutted by fire a few years ago, but the walls appear relatively unaffected (Fig. 26). There is a later lean-to to the south, which is one of the buildings around a stock yard, which retains in some places older cobbles. Most of these buildings are used for storage. Some still have feeding mangers.

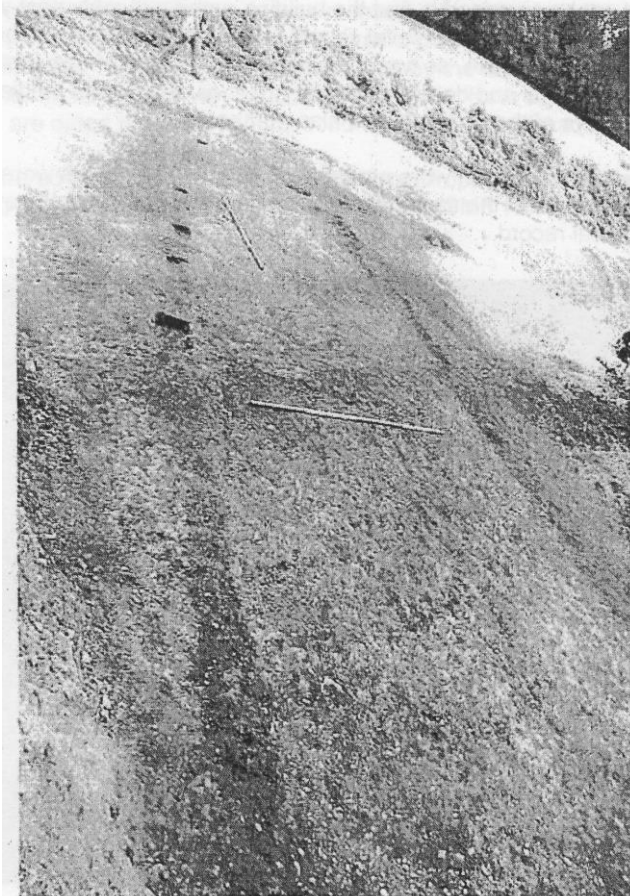
Figure 5: Photograph of detail of site showing post-holes
