# **HEREFORDSHIRE ARCHAEOLOGICAL NEWS**

**HAN 82 2011**

**WOOLHOPE CLUB  
ARCHAEOLOGICAL RESEARCH SECTION**

## **A survey of *The Creswells*, Sutton St Michael by Rosalind Lowe**

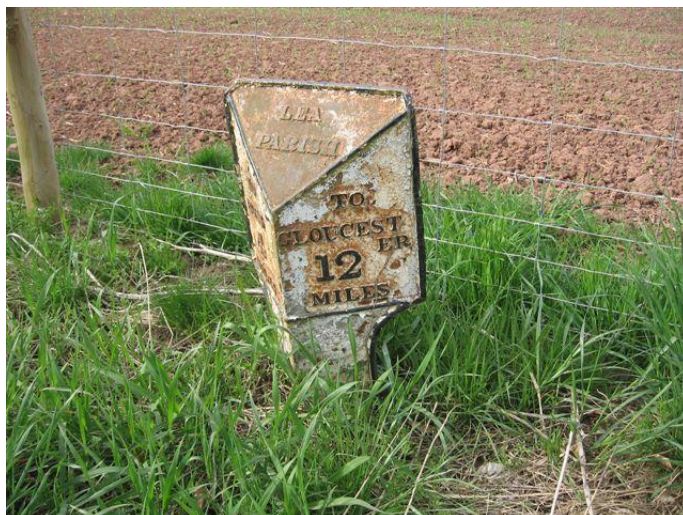
**1. Lea - MP on Glos/Her (A40) at Castle End Ross 4/Glos 12 found 654217  
grubby condition**

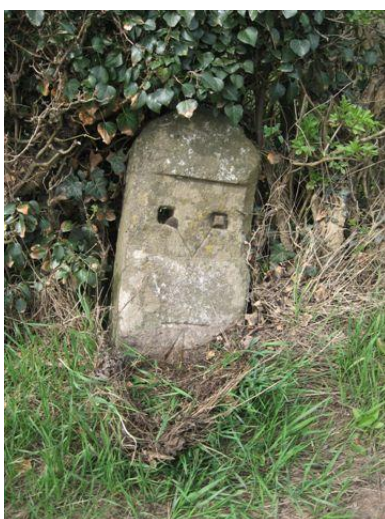
**2 Upton Bishop - MS near Crow Hill found 640265  
stone hidden in hedge, no writing, plate missing, bolt holes**

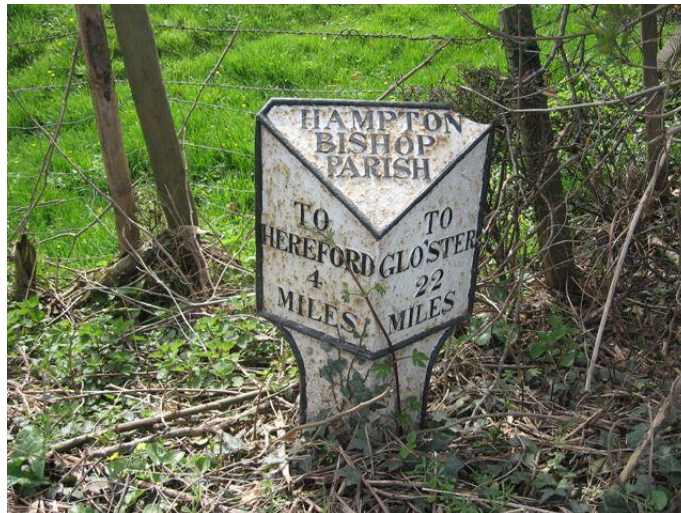
6. Hampton Bishop - MP near bridge Her 4/Glos 22 found 567374  
Chipped top, in hedge, bit grubby

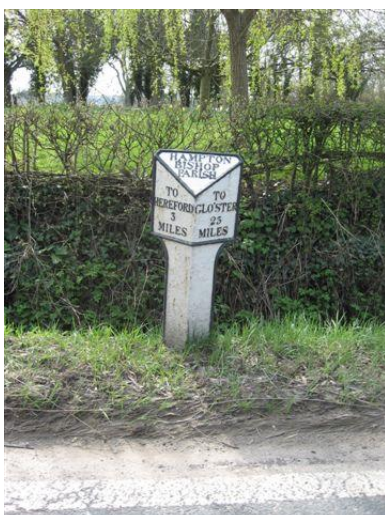
**7. Hampton Bishop - MP in village Her3/Glos23 found 552381 in good condition**

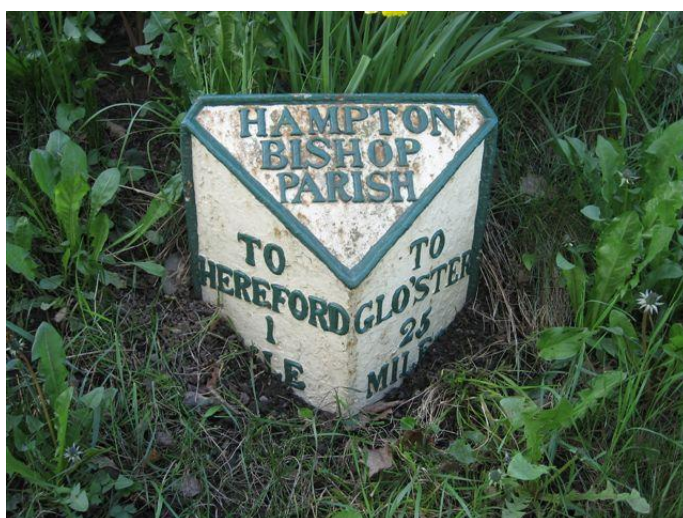
**9. Hampton Bishop - Salmon pub Her1/Glos25 found 524392 all words visible, otherwise hidden in bank, good condition**

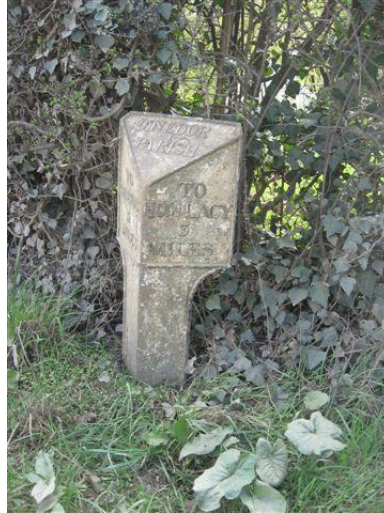
**10, Dinedor - MP after Railway at Rotherwas Her3/HL3 found 538378**  
**grubby and covered in brambles**

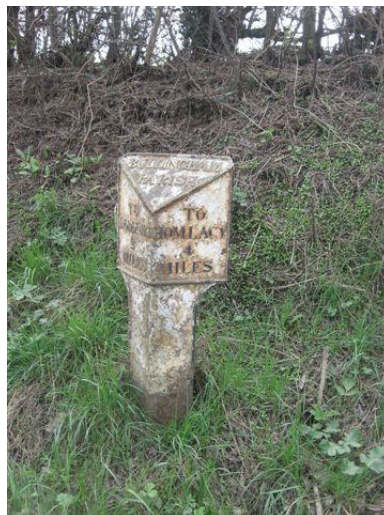
**11. Bullingham - MP Bullingham after 2nd rail bridge Her2/HL4 found 522382**  
**very grubby**

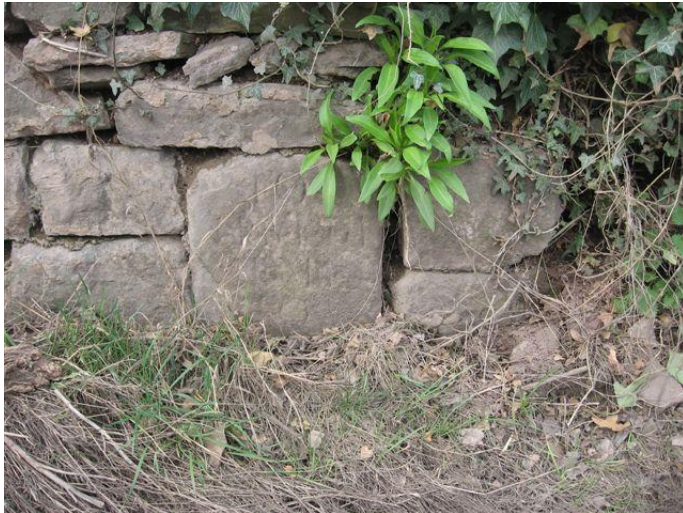
**12. Hentland - MS at Shepponhill Her 8 weathered in wall,  
found 550278**

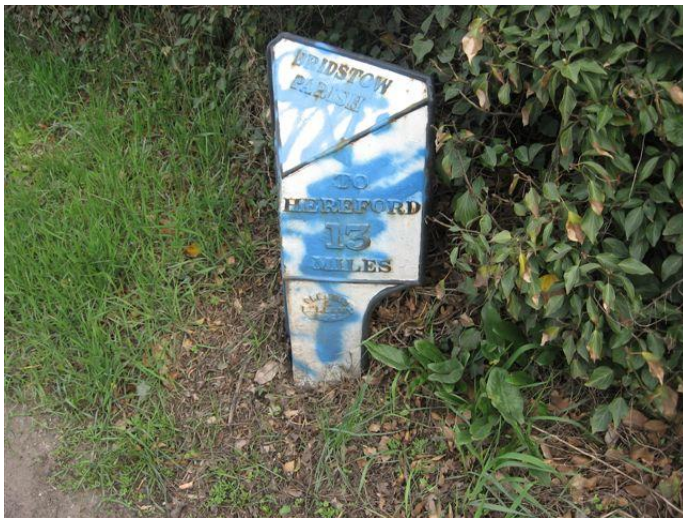
**13. Bridstow - MP on A40 TP 1726 altered route Her13/Ross1 found 584245  
defaced, Perkins & Bellamy**

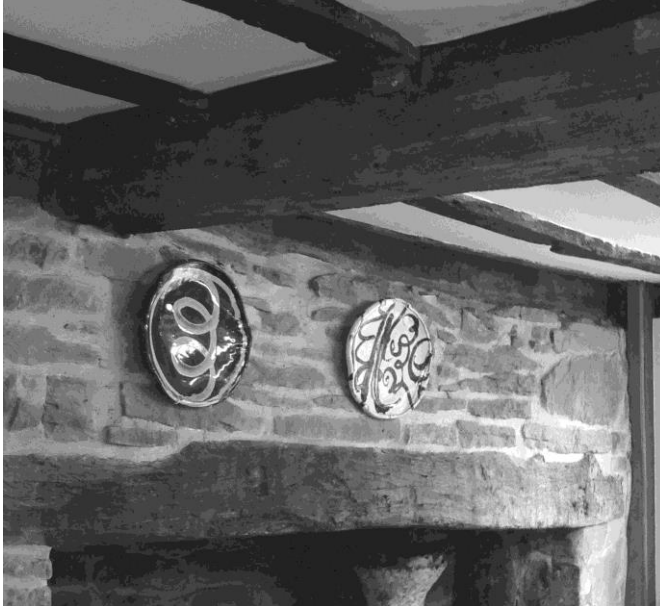
**Figure 15. Lintel of kitchen fireplace and beam (RS)**

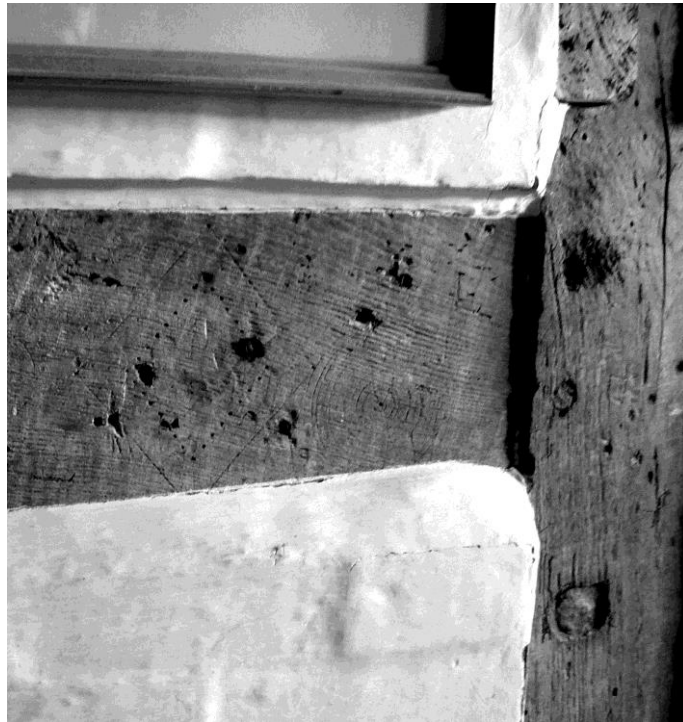
**Figure 18. Symbol in a horizontal timber in the sitting room (RS)**

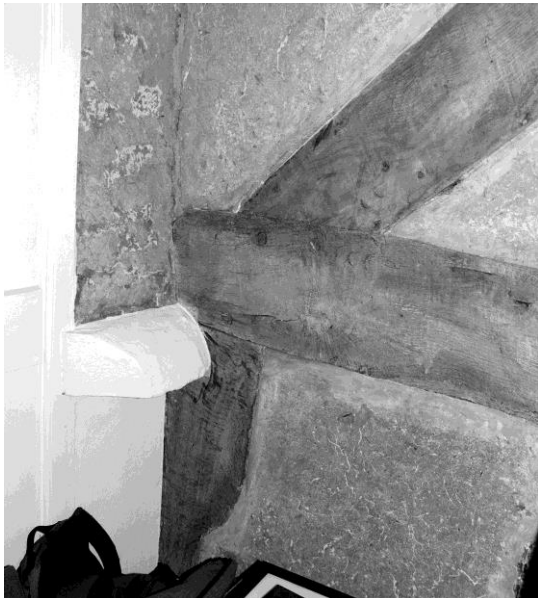
**Figure 19. Junction of the older kitchen block roof (to the right) and a timber of the sitting room block (RS)**

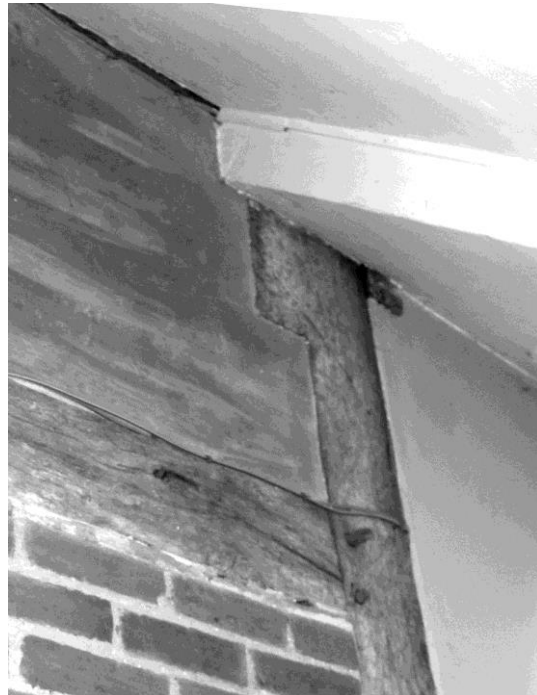
**Figure 20. Possible attachment trench for a pentice support (RL)**

At some time the building was extended on the north side, but the sequence of events is difficult to work out. It seems quite possible that there was originally a pentice. There is some evidence for this on the outside of the original north wall, where there are at least two places where the timber uprights have trenches where the pentice supports could have been connected (fig. 20). What is not obvious from the plan is that the floor of the wrap-around extension under the catslide roof is not only at a much lower level than the floor level of the older part of the house, but also that there is a considerable slope from the kitchen end of the extension towards the cider mill (fig. 21). The kitchen end of the extension now sticks out past the line of the original kitchen block (see fig. 22), but from evidence in the north wall of the extension this is a later addition.

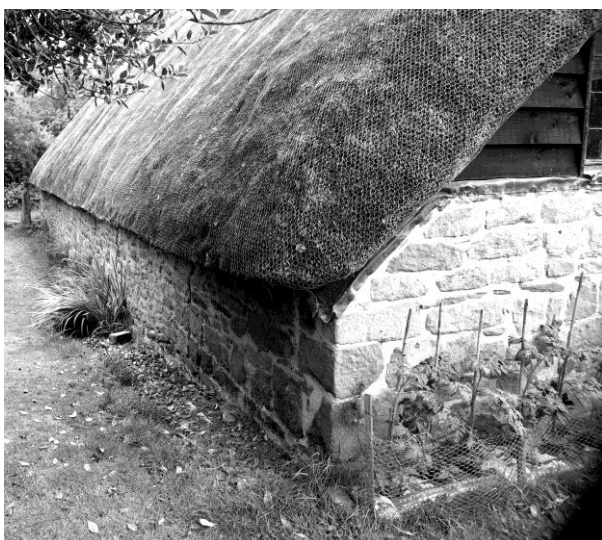
**Figure 21. Slope of ground level of extension. (RL)**

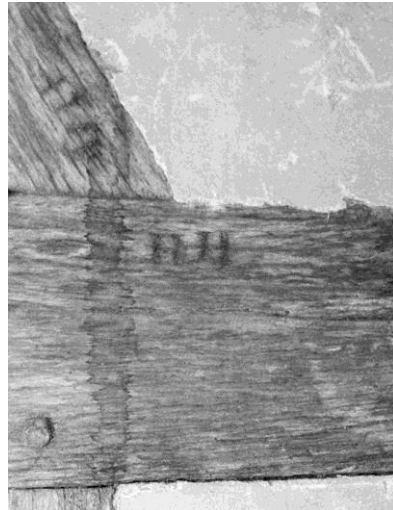
**Figure 24. Punched carpenters' marks (RS)**

Inside the wider end of the extension where the cider mill lies some of the earlier thatch has been exposed under plastic sheeting. The extension has no upper floor along its northern wall as the slope of the roof is too great, but there is an upper floor above the cider mill, formerly a hay-loft accessed from outside, but now there is an internal staircase to it. In this room the end of the upper floor of the sitting room block is exposed (Fig. 23). This timber framing would have been open to the outside. There are some punched carpenters' marks (Fig. 24)

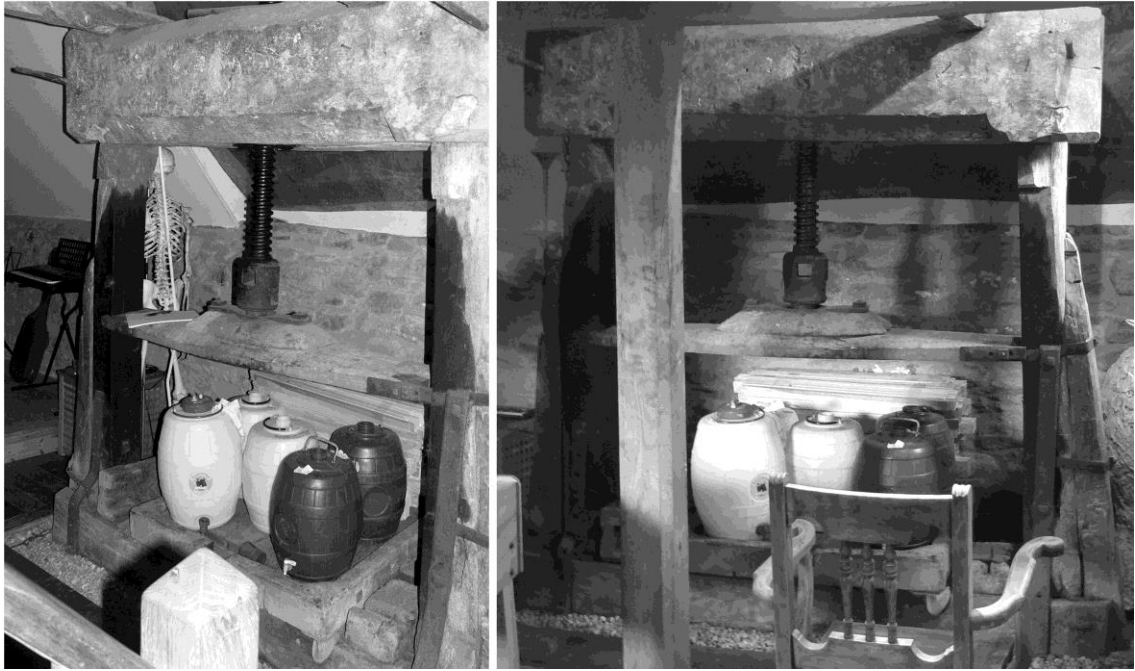
**Figure 26. Two views of the cider press (RL, RS)**

It would seem that at some stage the original (conjectural) pentice was converted into a covered space by erecting a wall on the north side of the building platform and throwing a roof across from it to the house roof. The further extension to the hay loft with cider mill under and the extension of the catslide roof (at both ends) to the current extent may have happened in two phases. The other feature of this lower level is the cider press (fig. 26).

z by a single wooden peg seen projecting from the beam. This, in effect, makes it easily demountable, though it must weigh a considerable amount. The timber of the beam has a rich patina and it was impossible to tell what it was. The end stops are beautifully and elegantly carved. The metal screw for the press is almost certainly a replacement for an original in timber.

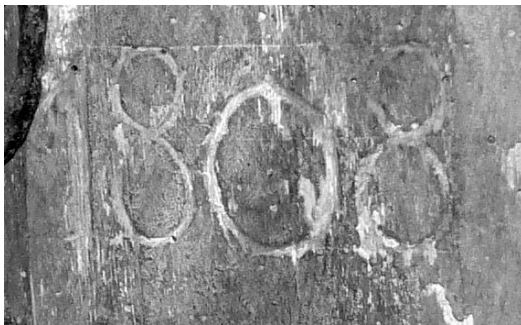
**Figure 27. Date on the cider press upright**

The enclosure map (1807-8, probably) does not show the addition to the western end of the catslide roof, and in fact the extra building containing the cider press and mill does not seem to be there either. It seems that a good case can be made for dating this to 1808.
