Geology Exposure Goodrich Dry Arch

Grid Reference: SO 57508 19196  
Latitude: 51.869706      Longitude: -2.6185605  
Date: December 2018

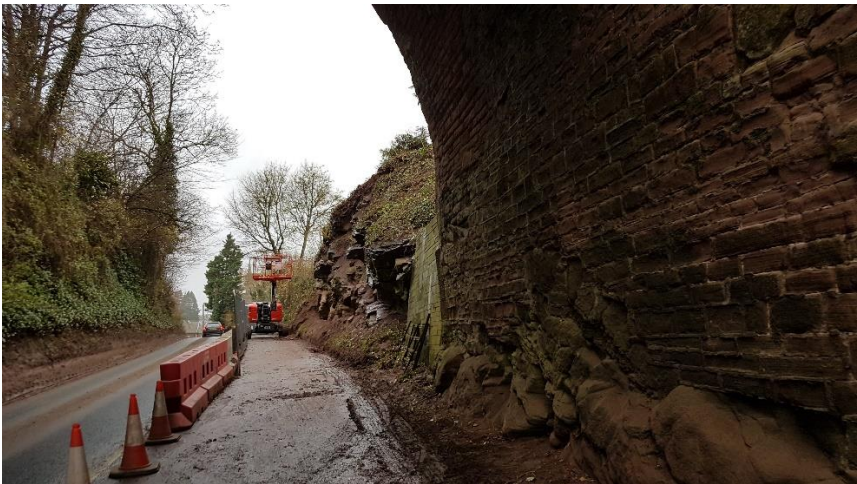
Figure 1. The exposure on the north (right) of the road between the digger and the buttress of the Dry Arch.

The new road necessitated making a deep cutting through a ridge which carried the Goodrich to Welsh Bicknor road. A viaduct to carry the road was built and is known locally as the Dry Arch. The cutting, overgrown with small trees and scrub, recently became unstable and had to be cleared. In the process the sandstone strata became visible and could be photographed while a protective barrier ran along the cutting – it is not usually accessible to pedestrians as the road is dangerous. It is not possible to photograph the exposure from the other side of the road.

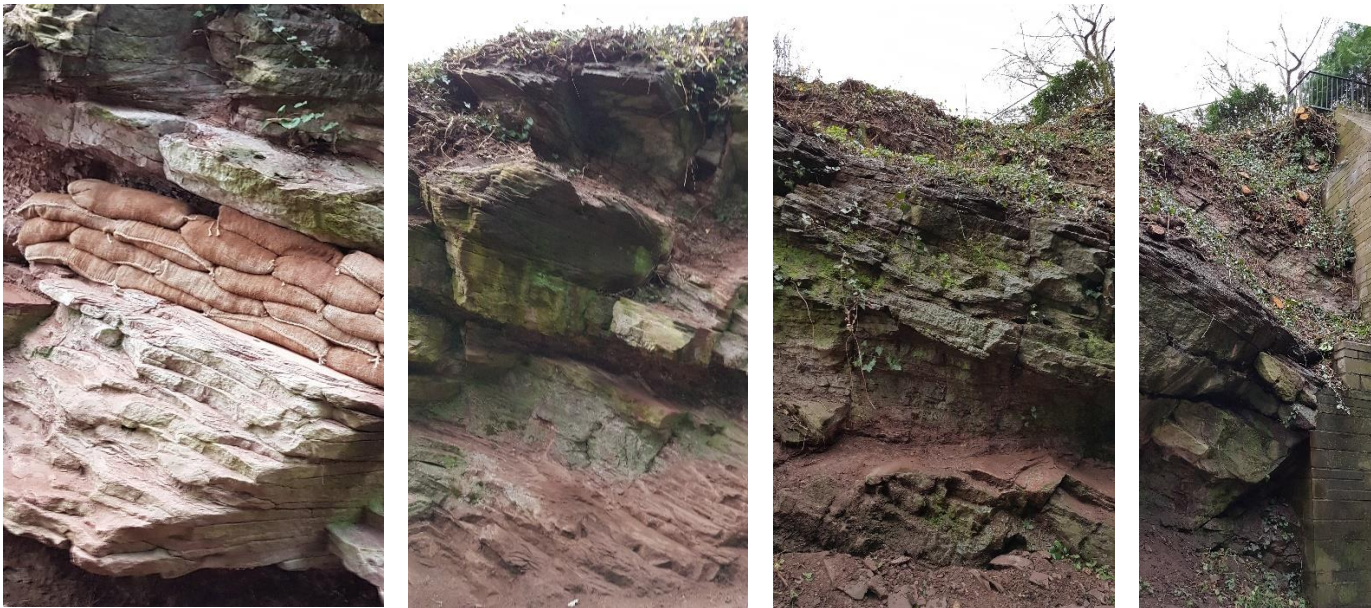
Figure 3. Exposures of north bank of cutting from west to east.

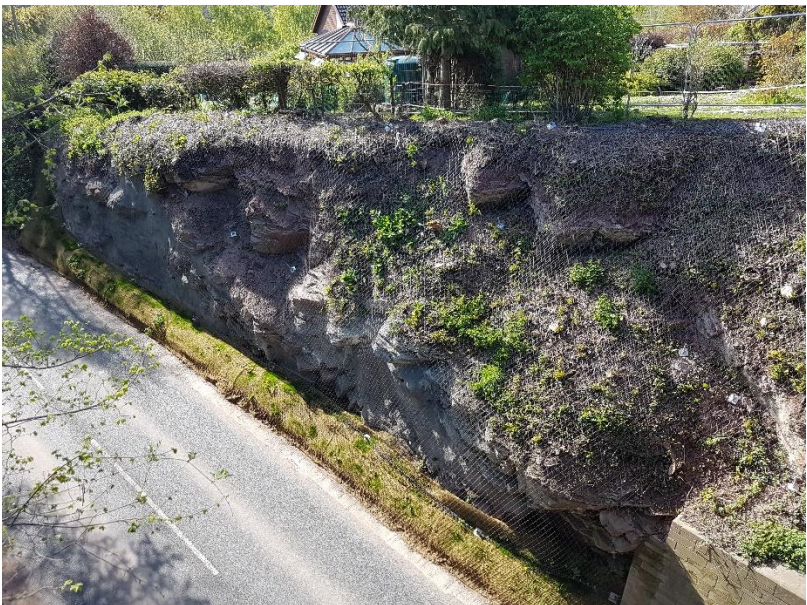
The work was completed in early 2019. As well as several places where missing sections of strata were supported by sandbags a cement(?) spray was fired at the strata and wire mesh was fixed to bolts fired into the bank. A rubberised mat was placed just above road level and as at April 2019 vegetation is already growing through this, as at other places on the bank. It remains to be seen whether this costly exercise will last. The rocks here are the Brownstones Formation, the highest part of the Lower Devonian. Massive red sandstone beds dip at a low angle to the south east. There are also muddier layers on which slippage takes place when they become lubricated after heavy rain. There was a similar slip on the minor road from Crocker’s Ash to Little Doward some years ago.
